Access Compliance Report Public Rights-of-Way (Curb Ramps)

Intersection ID: 53124 Main Street: SHARON VIEW RD **Cross Street: CALVET CT** Location:

Initial Pass/Fail: Fail **Overall Compliance: No ADA ID: 22FBAEEEFBA4** Ramp Type: PerpDiag Severity Score: 13.75

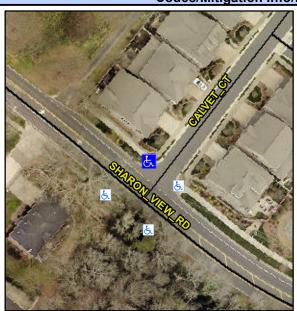
Not Found, R304.2.2, R304.5.3

Compliance Description Data Compliance Description No N/A Ramp Length (in) 53.5 No Yes Ramp Width (in) 48.0 N/A N/A Flare Type LT N/A N/A N/A N/A Flare Slope LT (%) N/A Flare Traversable LT? N/A N/A N/A N/A N/A Landing Length (in) N/A Landing Width (in) N/A N/A N/A N/A N/A Landing Slope (%) N/A Landing X Slope (%) N/A N/A N/A Landing Curb? (Y/N) N/A N/A N/A N/A Shared Landing? N/A **Gutter Ponding?** N/A N/A N/A Gutter Lip Ht (in) N/A N/A N/A Painted X Walk1? No N/A X Walk 1 Direction To SW N/A N/A N/A X Walk 1 Width (in) X Walk 1 Slope (%) 1.7 X Walk 1 X Slope (%) 3.3

Remove & Replace Curb Ramp With Two New Directional Ramps or Equivalent.
