Access Compliance Report

Public Rights-of-Way

(Curb Ramps)

Intersection ID: 10040110	Main Street: TUCKASEEGEE_RD	Cross Street: N/A	Location: S
ADA ID: 22FF5C4CFBCA	Ramp Type: BlendTrans2	Initial Pass/Fail: Fail	Overall Compliance: No
		Severity Score: 8.75

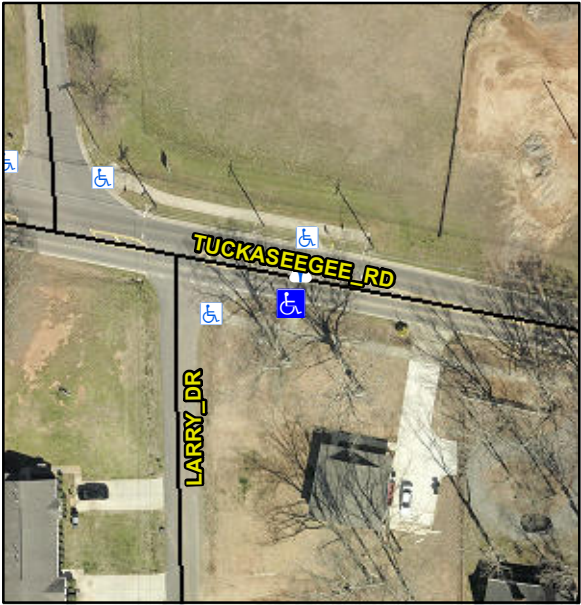
52.5	Ramp Length (in)	N/A
			47.5	Ramp Width (in)	N/A
			N/A	Flare Type LT	N/A
			N/A	Flare Type RT	N/A
			N/A	Flare Slope LT (%)	N/A
			N/A	Flare Slope RT (%)	N/A
			N/A	Flare Traversable LT?	N/A
			N/A	Flare Traversable RT?	N/A
			N/A	DWS Provided?	N/A
			N/A	DWS Contrast?	N/A
			N/A	DWS Length (in)	N/A
			N/A	DWS Full Width?	N/A
			N/A	DWS Offset (in)	N/A
			N/A	Gutter Ponding?	N/A
			N/A	Gutter X Slope (%)	N/A
			No	Painted X Walk1?	N/A
			To N	Painted X Walk2?	N/A
			N/A	X Walk 1 Direction	N/A
			N/A	X Walk 2 Direction	N/A
<p>Street 1 Name</p> <p>Stop Condition-Street 1</p> <p>Street 2 Name</p> <p>Stop Condition-Street 2</p>			0.6	X Walk 1 Width (in)	N/A

0.6	X Walk 1 Slope (%)	N/A
			1.0	X Walk 2 Width (in)	N/A
			1.0	X Walk 2 Slope (%)	N/A
			1.0	X Walk 2 X Slope (%)	N/A
			N/A	X Walk 1 X Slope (%)	N/A
			N/A	Ramp inside XWalk1?	N/A
			N/A	Ramp inside XWalk2?	N/A

1.0	Road Slope (%)	N/A
			0.6	Clear Space?	N/A
			0.6	Clear Space to XWalk (in)	N/A
			N/A	Road X Slope (%)	N/A
			N/A	Storm Grate/Utility Hazard?	N/A
			N/A	Storm Grate/Utility Type	N/A
			N/A	Any Obstructions?	N/A
			N/A	Obstruction Type	N/A
			N/A	Surface Condition? (G/P)	Good
			N/A	Curb Slope (%)	0.1

Possible Solutions:		Compliance	Description	Data
	Remove & Replace Curb Ramp With Two New Directional Ramps or Equivalent.		Yes	BlendTrans Slope (%)	1.5
			No	BlendTrans XSlope (%)	0.1
			N/A	Flare Type LT	N/A
			N/A	Flare Type RT	N/A
			N/A	Flare Slope LT (%)	N/A
			N/A	Flare Slope RT (%)	N/A
			N/A	Flare Traversable LT?	N/A
			N/A	Flare Traversable RT?	N/A
			N/A	DWS Provided?	N/A
			N/A	DWS Contrast?	N/A
			N/A	DWS Length (in)	N/A
			N/A	DWS Full Width?	N/A
			N/A	DWS Offset (in)	N/A
			N/A	Gutter Ponding?	N/A
			N/A	Gutter X Slope (%)	N/A
			N/A	Painted X Walk1?	N/A
			N/A	Painted X Walk2?	N/A
			N/A	X Walk 1 Direction	N/A
			N/A	X Walk 2 Direction	N/A
<p>Surveyor Notes:</p> <p>N/A</p> <p>PROW/ADA:</p> <p>R304.5.1</p>			Data	Description	Data

Total Cost: \$ 3200.00
