Access Compliance Report Public Rights-of-Way (Curb Ramps)

Intersection ID: N/A Main Street: SHARON_LAKES_RD Cross Street: HARVEST_LN Location: NE

ADA ID: 230BFAA739BC Ramp Type: Perp Initial Pass/Fail: Pass Overall Compliance: No Severity Score: 7.5

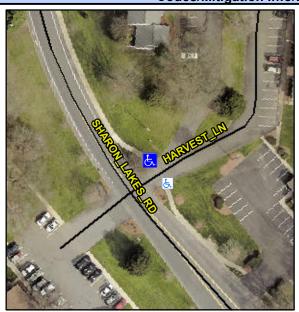
Street 1 Name HARVEST LN
Stop Condition-Street 2 None
Street 2 Name N/A
Stop Condition-Street 1 N/A

Not Found, R304.2.2-Perp, R304.3.2-Para, R305.1.4, R304.5.4

Remove & Replace Entire Ramp.
Remove & Replace Gutter.
