Access Compliance Report

Public Rights-of-Way

(Curb Ramps)

Intersection ID: N/A	Main Street: OUTLETS_BV	Cross Street: DESIGNER_DR	Location: SE
ADA ID: 2315987EB2E4	Ramp Type: Perp	Initial Pass/Fail: Fail	Overall Compliance: No
			Severity Score: 21.25

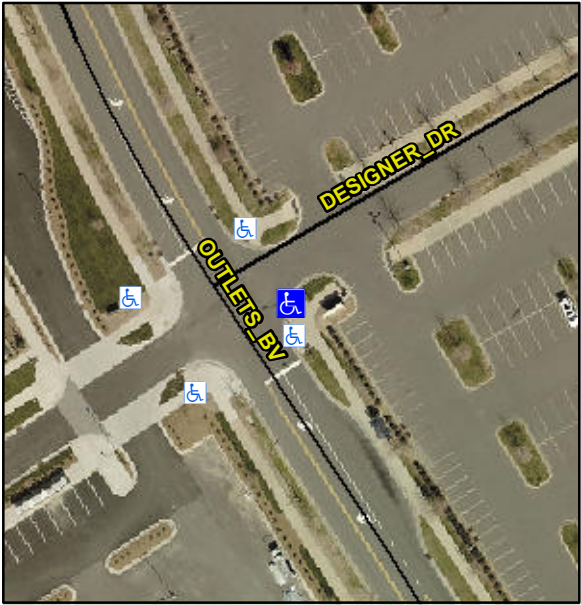
Possible Solutions:		Compliance	Description	Data
	Remove & Replace Entire Ramp.		N/A	Ramp Length (in)	94.0
			No	Ramp Width (in)	46.0
			N/A	Flare Type LT	N/A
			N/A	Flare Slope LT (%)	N/A
			N/A	Flare Traversable LT?	N/A
			N/A	Landing Length (in)	N/A
			N/A	Landing Width (in)	N/A
			N/A	Landing Slope (%)	N/A
			N/A	Landing X Slope (%)	N/A
<p>Surveyor Notes:</p> <p>N/A</p> <p>PROW/ADA:</p> <p>R304.5.1, R304.5.3</p>			N/A	Flare Type RT	N/A
			N/A	Flare Slope RT (%)	N/A
			N/A	Flare Traversable RT?	N/A
			N/A	DWS Provided?	N/A
			N/A	DWS Contrast?	N/A
			N/A	DWS Length (in)	N/A
			N/A	DWS Full Width?	N/A
			N/A	DWS Offset (in)	N/A
			N/A	Shared Landing?	N/A
			N/A	Gutter Ponding?	N/A
			N/A	Gutter Lip Ht (in)	N/A
			N/A	Painted X Walk1?	No
				X Walk 1 Direction	To N
			N/A	X Walk 1 Width (in)	N/A
				X Walk 1 Slope (%)	1.9
				X Walk 1 X Slope (%)	1.1

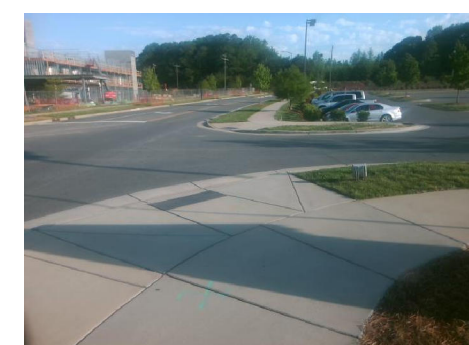
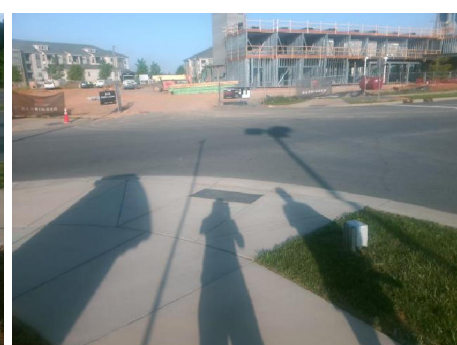
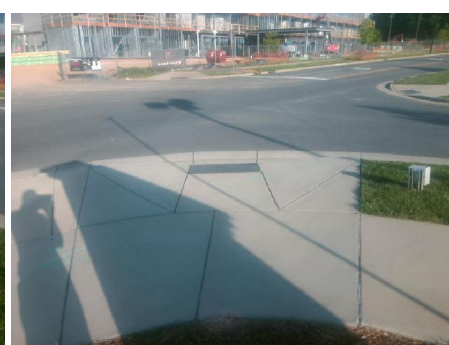
N/A	Ramp inside XWalk1?	N/A
				Road Slope (%)	N/A
				Road X Slope (%)	N/A
			N/A	Any Obstructions?	N/A
				Obstruction Type	
Total Cost:		\$ 1850.00			
			N/A		N/A
			Yes	Surface Condition? (G/P)	Good
