# Access Compliance Report

## Public Rights-of-Way

### (Curb Ramps)

| Intersection ID: 10751 | Main Street: STATESVILLE_AV | Cross Street: OLIVER_ST | Location: NW |

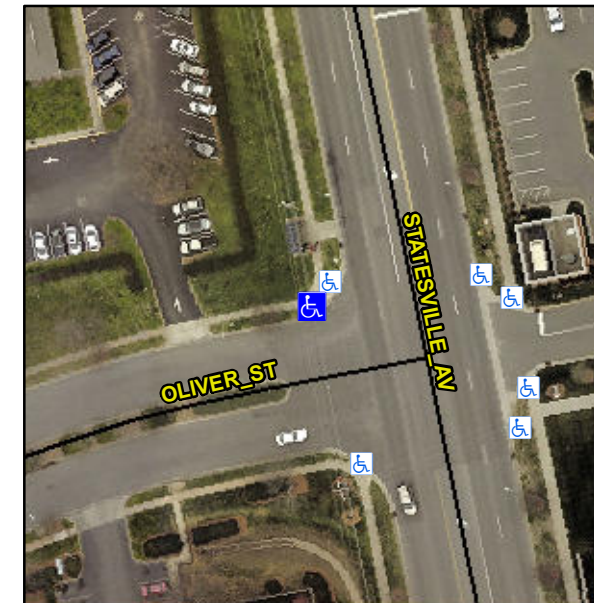
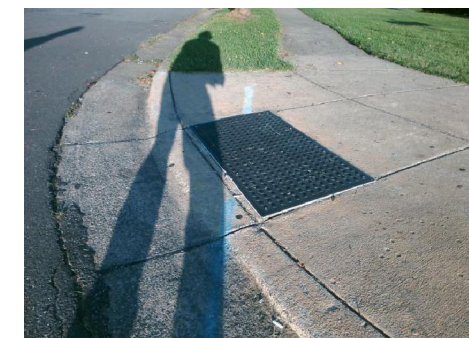
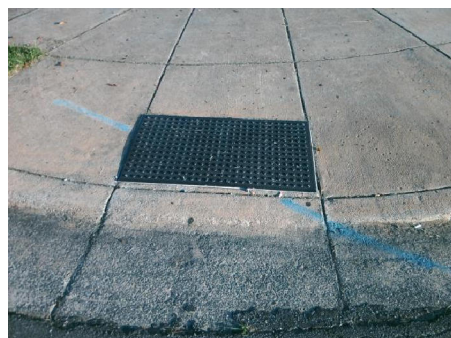
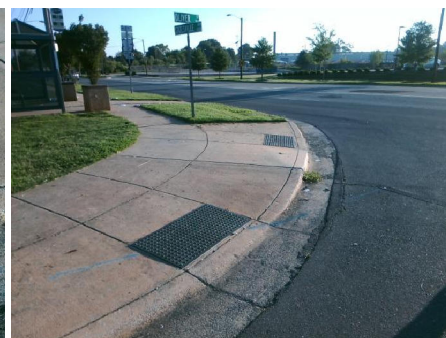
| ADA ID: 231D233F227E | Ramp Type: Perp | Initial Pass/Fail: Fail | Overall Compliance: No |

**Not Found, R304.5.1, R304.2.2**

| Compliance | Description | Data | Compliance | Description | Data |
|---|---|---|---|---|---|
| N/A | Ramp Length (in) | 58.5 | No | Ramp Slope (%) | 8.4 |
| No | Ramp Width (in) | 43.0 | Yes | Ramp XSlope (%) | 2.0 |

**Remove & Replace Entire Ramp.**
