Access Compliance Report

Public Rights-of-Way

(Curb Ramps)

Intersection ID: 11232	Main Street: BARRINGTON_DR	Cross Street: MILTON_RD	Location: SW
ADA ID: 23268938CE94	Ramp Type: Perp	Initial Pass/Fail: Fail	Overall Compliance: No
Severity Score: 31.25			
Codes/Mitigation Info/Possible Solution		Field Measurements/Component Compliance

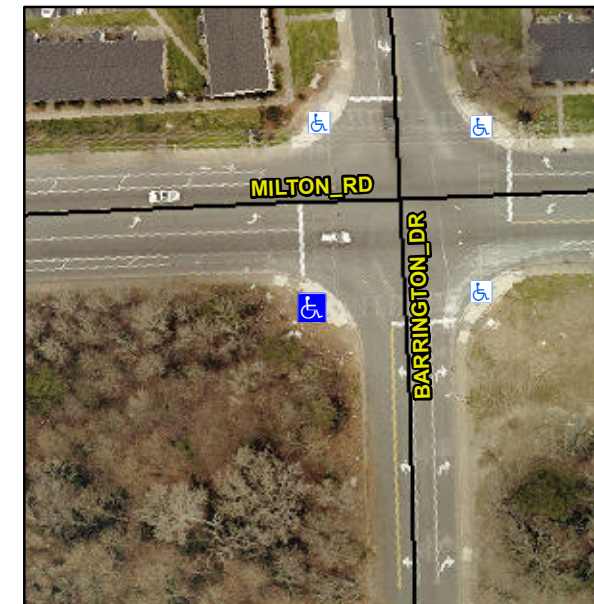
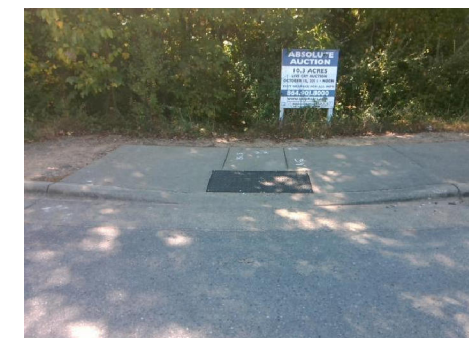
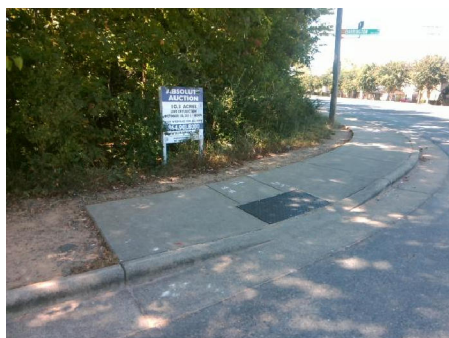
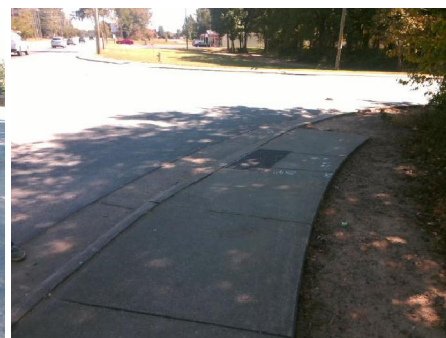
Not Found, R304.5.1, R304.2.2, R304.5.3

Compliance	Description	Data	Compliance	Description	Data
N/A	Ramp Length (in)	59.0	No	Ramp Slope (%)	8.8
No	Ramp Width (in)	32.0	No	Ramp XSlope (%)	2.2
N/A	Flare Type LT	N/A	N/A	Flare Type RT	N/A
N/A	Flare Slope LT (%)	N/A	N/A	Flare Slope RT (%)	N/A
N/A	Flare Traversable LT?	N/A	N/A	Flare Traversable RT?	N/A
N/A	Landing Length (in)	N/A	N/A	DWS Provided?	N/A
N/A	Landing Width (in)	N/A	N/A	DWS Contrast?	N/A
N/A	Landing Slope (%)	N/A	N/A	DWS Length (in)	N/A
N/A	Landing X Slope (%)	N/A	N/A	DWS Full Width?	N/A
N/A	Landing Curb? (Y/N)	N/A	N/A	DWS Offset (in)	N/A
N/A	Shared Landing?	N/A			
N/A	Gutter Ponding?	N/A	N/A	Gutter Slope (%)	N/A
N/A	Gutter Lip Ht (in)	N/A	N/A	Gutter X Slope (%)	N/A
N/A	Painted X Walk1?	No	N/A	Painted X Walk2?	N/A
	X Walk 1 Direction	To E		X Walk 2 Direction	N/A
N/A	X Walk 1 Width (in)	N/A	N/A	X Walk 2 Width (in)	N/A
	X Walk 1 Slope (%)	1.3		X Walk 2 Slope (%)	N/A
	X Walk 1 X Slope (%)	3.3		X Walk 2 X Slope (%)	N/A

N/A	Ramp inside XWalk1?	N/A	N/A	Ramp inside XWalk2?	N/A
	Road Slope (%)	N/A	N/A	Clear Space?	N/A
	Road X Slope (%)	N/A	N/A	Clear Space to XWalk (in)	N/A
N/A	Any Obstructions?	N/A	N/A	Storm Grate/Utility Hazard?	N/A
	Obstruction Type			Storm Grate/Utility Type	
		N/A			N/A
			Yes	Surface Condition? (G/P)	Good

Possible Solutions:

Remove & Replace Entire Ramp.
