Access Compliance Report

Public Rights-of-Way

(Curb Ramps)

Intersection ID: 10031826	Main Street: MILLWRIGHT_LN	Cross Street: N/A	Location: SW
ADA ID: 232E14F7331F	Ramp Type: Perp	Initial Pass/Fail: Fail	Overall Compliance: No
		Severity Score: 25

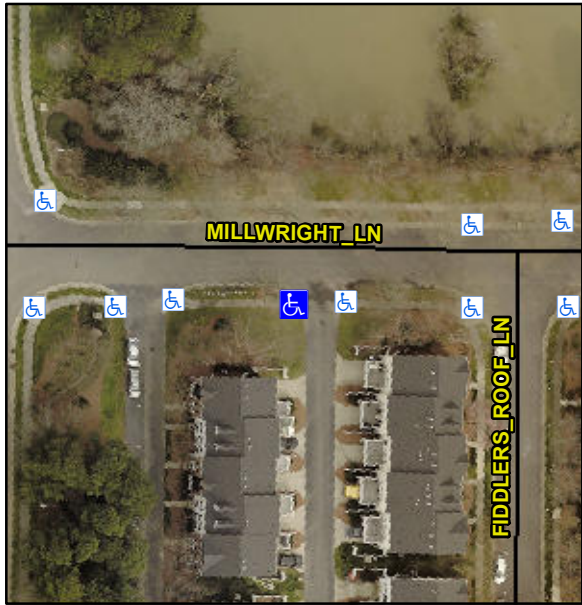
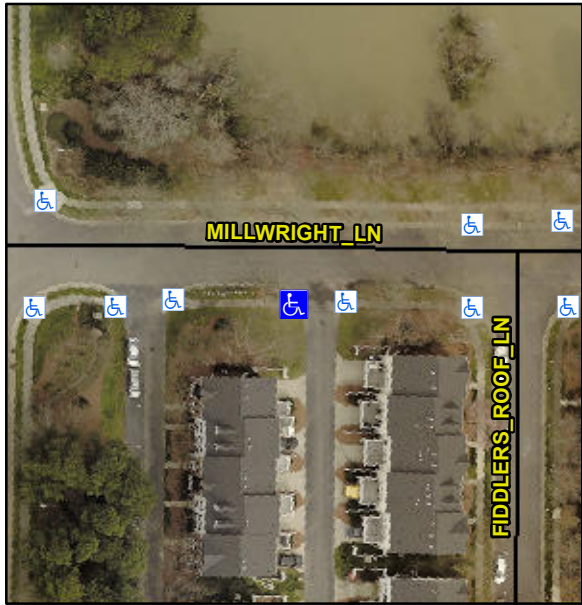
Possible Solutions:		Compliance	Description	Data	Compliance	Description	Data
	Remove & Replace Entire Ramp.		N/A	Ramp Length (in)	115.0	No	Ramp Slope (%)	10.3
			Yes	Ramp Width (in)	48.0	No	Ramp XSlope (%)	5.8
			N/A	Flare Type LT	N/A	N/A	Flare Type RT	N/A
			N/A	Flare Slope LT (%)	N/A	N/A	Flare Slope RT (%)	N/A
			N/A	Flare Traversable LT?	N/A	N/A	Flare Traversable RT?	N/A
			N/A	Landing Length (in)	N/A	N/A	DWS Provided?	N/A
			N/A	Landing Width (in)	N/A	N/A	DWS Contrast?	N/A
			N/A	Landing Slope (%)	N/A	N/A	DWS Length (in)	N/A
			N/A	Landing X Slope (%)	N/A	N/A	DWS Full Width?	N/A

X Walk 1 Direction	To SE		X Walk 2 Direction	N/A
			N/A	X Walk 1 Width (in)	N/A	N/A	X Walk 2 Width (in)	N/A
				X Walk 1 Slope (%)	4.4		X Walk 2 Slope (%)	N/A
				X Walk 1 X Slope (%)	3.7		X Walk 2 X Slope (%)	N/A
			N/A	Ramp inside XWalk1?	N/A	N/A	Ramp inside XWalk2?	N/A
PROW/ADA:			Road Slope (%)	N/A	N/A	Clear Space?	N/A	
			Road X Slope (%)	N/A	N/A	Clear Space to XWalk (in)	N/A	
		N/A	Any Obstructions?	N/A	N/A	Storm Grate/Utility Hazard?	N/A	
			Obstruction Type			Storm Grate/Utility Type		
				N/A			N/A	
					Yes	Surface Condition? (G/P)	Good	
Total Cost:		\$	1850.00
