Access Compliance Report Public Rights-of-Way (Curb Ramps)

Intersection ID: 6998 Main Street: NEVIN_RD Cross Street: STATESVILLE_RD Location: SE

ADA ID: 2332BDD104E2 Ramp Type: Para Initial Pass/Fail: Fail Overall Compliance: No Severity Score: 13.75

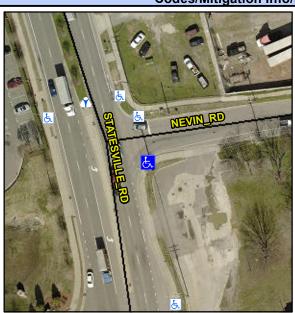
Field Measurements/Component Compliance							
Compl	iance Description	Data	Compl	iance Description	Data		
N/A	Ramp Length LT (in)	49.0	N/A	Ramp Length RT (in)	52.0		
Yes	Ramp Width LT (in)	83.0	Yes	Ramp Width RT (in)	83.5		
Yes	Ramp Slope LT (%)	6.4	No	Ramp Slope RT (%)	9.7		
No	Ramp XSlope LT (%)	2.7	Yes	Ramp XSlope RT (%)	2.0		
N/A	Landing Length (in)	N/A	N/A	DWS Provided?	N/A		
N/A	Landing Width (in)	N/A	N/A	DWS Contrast?	N/A		
N/A	Landing Slope (%)	N/A	N/A	DWS Length (in)	N/A		
N/A	Landing X Slope (%)	N/A	N/A	DWS Full Width?	N/A		
N/A	Landing Curb? (Y/N)	N/A	N/A	DWS Offset (in)	N/A		
N/A	Shared Landing?	N/A					
N/A	Gutter Ponding?	N/A	N/A	Gutter Slope (%)	N/A		
N/A	Gutter Lip Ht (in)	N/A	N/A	Gutter X Slope (%)	N/A		
N/A	Painted X Walk1?	No	N/A	Painted X Walk2?	N/A		
	X Walk 1 Direction	To N		X Walk 2 Direction	N/A		
N/A	X Walk 1 Width (in)	N/A	N/A	X Walk 2 Width (in)	N/A		
	X Walk 1 Slope (%)	1.9		X Walk 2 Slope (%)	N/A

X Walk 1 X Slope (%)	0.2		X Walk 2 X Slope (%)	N/A		
N/A	Ramp inside XWalk1?	N/A	N/A	Ramp inside XWalk2?	N/A		
	Road Slope (%)	N/A	N/A	Clear Space?	N/A		
	Road X Slope (%)	N/A	N/A	Clear Space to XWalk (in)	N/A		
N/A	Any Obstructions?	N/A	N/A	Storm Grate/Utility Hazard?	N/A		
	Obstruction Type			Storm Grate/Utility Type			
		N/A			N/A		
			Yes	Surface Condition? (G/P)	Good		
			N/A	Curb Slope (%)	N/A

Possible Solutions:	Cor
Remove & Replace Entire Ramp.	N/A
·	Yes
	Yes
	No
	N/A
	N/A
Surveyor Notes:	N/A
N/A	N/A
	N/A
	N/A
	N/A
PROW/ADA:	N/A
R304.5.3, R304.3.2	N/A
	N/A
	N/A
