Access Compliance Report

Public Rights-of-Way

(Curb Ramps)

Intersection ID: 13153	Main Street: CAPITOL_DR	Cross Street: N/A	Location: NE
ADA ID: 233A62DA5D54	Ramp Type: ParaDiag	Initial Pass/Fail: Fail	Overall Compliance: No
Codes/Mitigation Info/Possible Solution		Field Measurements/Component Compliance	
Severity Score: 13.75

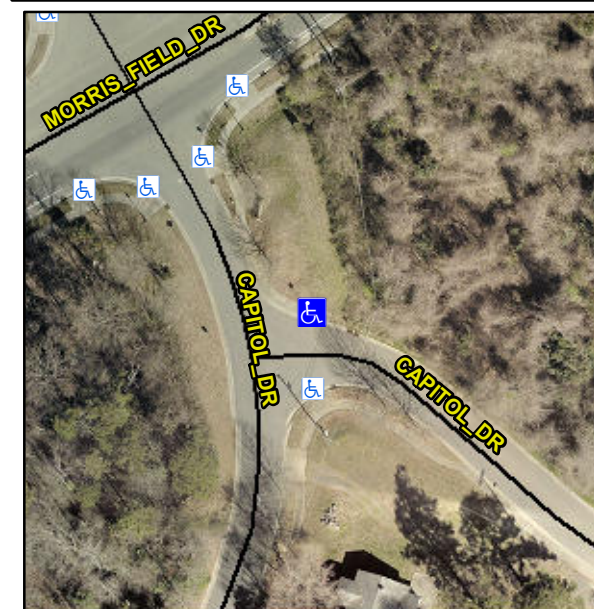
LT RP < 5%

Compliance	Description	Data	Compliance	Description	Data
N/A	Ramp Length LT (in)	64.0	N/A	Ramp Length RT (in)	75.0
Yes	Ramp Width LT (in)	60.0	Yes	Ramp Width RT (in)	60.0
Yes	Ramp Slope LT (%)	0.8	No	Ramp Slope RT (%)	9.0
No	Ramp XSlope LT (%)	3.6	No	Ramp XSlope RT (%)	4.7
N/A	Landing Length (in)	N/A	N/A	DWS Provided?	N/A
N/A	Landing Width (in)	N/A	N/A	DWS Contrast?	N/A
N/A	Landing Slope (%)	N/A	N/A	DWS Length (in)	N/A
N/A	Landing X Slope (%)	N/A	N/A	DWS Full Width?	N/A
N/A	Landing Curb? (Y/N)	N/A	N/A	DWS Offset (in)	N/A
N/A	Shared Landing?	N/A			
N/A	Gutter Ponding?	N/A	N/A	Gutter Slope (%)	N/A
N/A	Gutter Lip Ht (in)	N/A	N/A	Gutter X Slope (%)	N/A
N/A	Painted X Walk1?	No	N/A	Painted X Walk2?	No
	X Walk 1 Direction	To W		X Walk 2 Direction	To S
N/A	X Walk 1 Width (in)	N/A	N/A	X Walk 2 Width (in)	N/A
	X Walk 1 Slope (%)	1.6		X Walk 2 Slope (%)	6.1
	X Walk 1 X Slope (%)	7.8		X Walk 2 X Slope (%)	1.2
N/A	Ramp inside XWalk1?	N/A	N/A	Ramp inside XWalk2?	N/A

Road Slope (%)	3.8	N/A	Clear Space?	N/A
	Road X Slope (%)	5.5	N/A	Clear Space to XWalk (in)	N/A
N/A	Any Obstructions?	N/A	N/A	Storm Grate/Utility Hazard?	N/A
	Obstruction Type			Storm Grate/Utility Type	
		N/A			N/A
			Yes	Surface Condition? (G/P)	Good
			N/A	Curb Slope (%)	1.1

Possible Solutions:

Remove & Replace Curb Ramp With Two New Directional Ramps or Equivalent.
