Access Compliance Report

Public Rights-of-Way

(Curb Ramps)

Intersection ID: 50899	Main Street: DAVE_THOMAS_LN	Cross Street: SHANON_DARBY_LN	Location: SW
ADA ID: 233F9FE30EC8	Ramp Type: PerpDiag	Initial Pass/Fail: Fail	Overall Compliance: No
Severity Score: 12.5			
Codes/Mitigation Info/Possible Solution		Field Measurements/Component Compliance

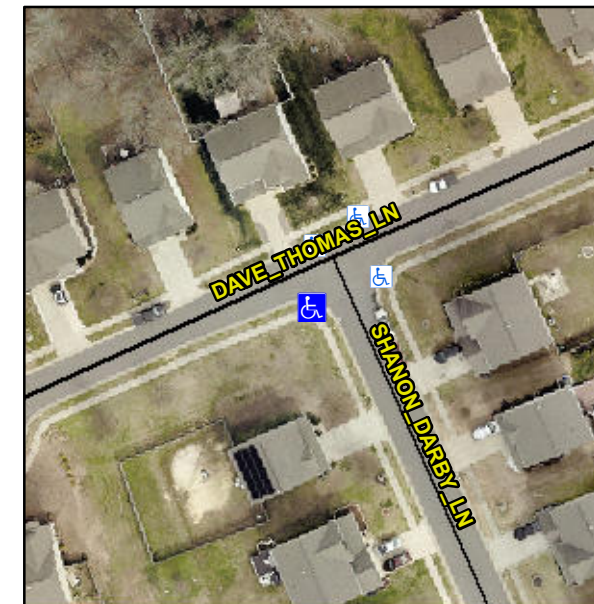
Not Found, R304.2.2

Compliance	Description	Data	Compliance	Description	Data
N/A	Ramp Length (in)	48.0	No	Ramp Slope (%)	8.5
Yes	Ramp Width (in)	48.0	Yes	Ramp XSlope (%)	1.5
N/A	Flare Type LT	N/A	N/A	Flare Type RT	N/A
N/A	Flare Slope LT (%)	N/A	N/A	Flare Slope RT (%)	N/A
N/A	Flare Traversable LT?	N/A	N/A	Flare Traversable RT?	N/A
N/A	Landing Length (in)	N/A	N/A	DWS Provided?	N/A
N/A	Landing Width (in)	N/A	N/A	DWS Contrast?	N/A
N/A	Landing Slope (%)	N/A	N/A	DWS Length (in)	N/A
N/A	Landing X Slope (%)	N/A	N/A	DWS Full Width?	N/A
N/A	Landing Curb? (Y/N)	N/A	N/A	DWS Offset (in)	N/A
N/A	Shared Landing?	N/A			
N/A	Gutter Ponding?	N/A	N/A	Gutter Slope (%)	N/A
N/A	Gutter Lip Ht (in)	N/A	N/A	Gutter X Slope (%)	N/A
N/A	Painted X Walk1?	No	N/A	Painted X Walk2?	No
	X Walk 1 Direction	To E		X Walk 2 Direction	To N
N/A	X Walk 1 Width (in)	N/A	N/A	X Walk 2 Width (in)	N/A
	X Walk 1 Slope (%)	5.7		X Walk 2 Slope (%)	0.3
	X Walk 1 X Slope (%)	3.6		X Walk 2 X Slope (%)	2.8

N/A	Ramp inside XWalk1?	N/A	N/A	Ramp inside XWalk2?	N/A
	Road Slope (%)	1.5	N/A	Clear Space?	N/A
	Road X Slope (%)	4.3	N/A	Clear Space to XWalk (in)	N/A
N/A	Any Obstructions?	N/A	N/A	Storm Grate/Utility Hazard?	N/A
	Obstruction Type			Storm Grate/Utility Type	
		N/A			N/A
			Yes	Surface Condition? (G/P)	Good

Remove & Replace Curb Ramp With Two New Directional Ramps or Equivalent.
