Access Compliance Report Public Rights-of-Way (Curb Ramps)

Intersection ID: 13806 Main Street: S_TRYON_ST Cross Street: WEST_BV Location: W

ADA ID: 234B9853B21A Ramp Type: Perp Initial Pass/Fail: Fail Overall Compliance: No Severity Score: 21.25

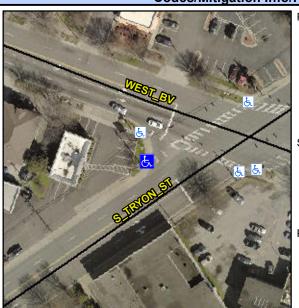
Field Measurements/Component Compliance								
Comp	liance Description	Data	Comp	liance D	escription	Data		
N/A	Ramp Length (in)	61.0	No	Ramp S	lope (%)	10.4		
No	Ramp Width (in)	40.0	Yes	Ramp X	Slope (%)	0.5		
N/A	Flare Type LT	N/A	N/A	Flare Ty	pe RT	N/A		
N/A	Flare Slope LT (%)	N/A	N/A	Flare SI	ope RT (%)	N/A		
N/A	Flare Traversable LT?	N/A	N/A	Flare Tr	aversable RT?	N/A		
N/A	Landing Length (in)	N/A	N/A	DWS Pr	ovided?	N/A		
N/A	Landing Width (in)	N/A	N/A	DWS Co	ontrast?	N/A		
N/A	Landing Slope (%)	N/A	N/A	DWS Le	ength (in)	N/A		
N/A	Landing X Slope (%)	N/A	N/A	DWS Fu	ıll Width?	N/A		
N/A	Landing Curb? (Y/N)	N/A	N/A	DWS Of	fset (in)	N/A		
N/A	Shared Landing?	N/A						
N/A	Gutter Ponding?	N/A	N/A	Gutter S	lope (%)	N/A		
N/A	Gutter Lip Ht (in)	N/A	N/A	Gutter X	Slope (%)	N/A		
N/A	Painted X Walk1?	Yes	N/A	Painted	X Walk2?	N/A		
	X Walk 1 Direction	To NE		X Walk	2 Direction	N/A		
N/A	X Walk 1 Width (in)	86.0	N/A	X Walk	2 Width (in)	N/A

X Walk 1 Slope (%)	1.1		X Walk	2 Slope (%)	N/A		
	X Walk 1 X Slope (%)	1.1		X Walk	2 X Slope (%)	N/A		
N/A	Ramp inside XWalk1?	Yes	N/A	Ramp in	side XWalk2?	N/A		
	Road Slope (%)	N/A	N/A	Clear Sp	pace?	N/A		
	Road X Slope (%)	N/A	N/A	Clear Sp	pace to XWalk (in)	N/A		
N/A	Any Obstructions?	N/A	N/A	Storm G	rate/Utility Hazard?	N/A		
	Obstruction Type			Storm G	rate/Utility Type			
		N/A				N/A		
			Yes	Surface	Condition? (G/P)	Good

Remove & Replace Entire Ramp.
