Access Compliance Report

Public Rights-of-Way

(Curb Ramps)

Intersection ID: 2920	Main Street: FILLIAN_LN	Cross Street: GLENDOCK_CT	Location: SW
ADA ID: 234FDB900724	Ramp Type: PerpDiag	Initial Pass/Fail: Fail	Overall Compliance: No
Severity Score: 37.5			
Codes/Mitigation Info/Possible Solution		Field Measurements/Component Compliance

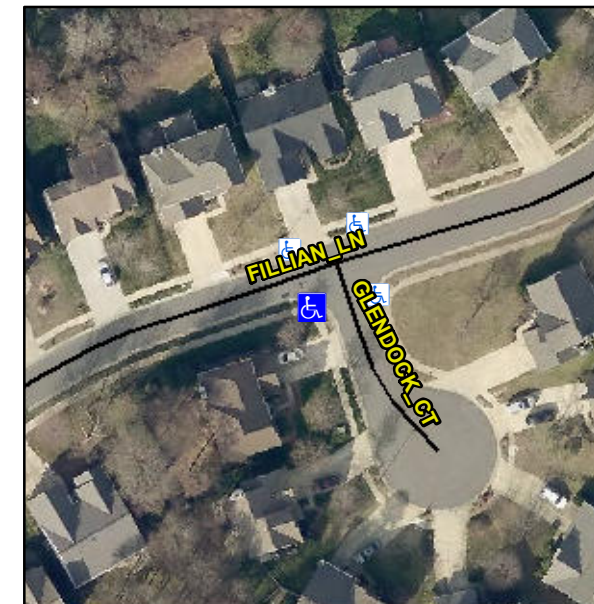
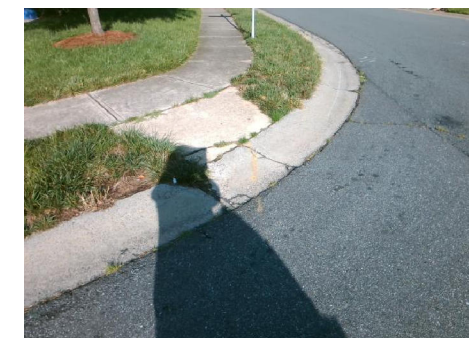
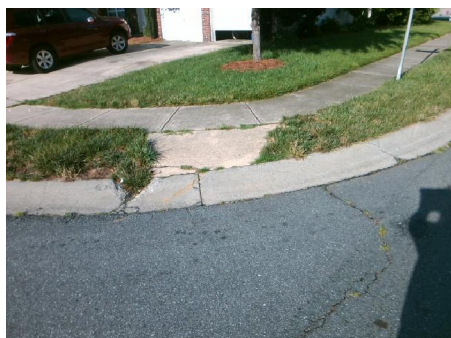
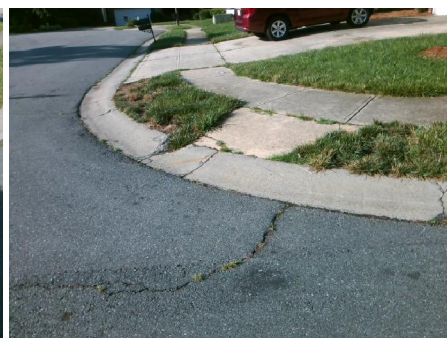
Not Found, R304.5.1, R304.2.2, R304.5.3, R302.7

Compliance	Description	Data	Compliance	Description	Data
N/A	Ramp Length (in)	43.5	No	Ramp Slope (%)	10.4
No	Ramp Width (in)	46.0	No	Ramp XSlope (%)	3.8
N/A	Flare Type LT	N/A	N/A	Flare Type RT	N/A
N/A	Flare Slope LT (%)	N/A	N/A	Flare Slope RT (%)	N/A
N/A	Flare Traversable LT?	N/A	N/A	Flare Traversable RT?	N/A
N/A	Landing Length (in)	N/A	N/A	DWS Provided?	N/A
N/A	Landing Width (in)	N/A	N/A	DWS Contrast?	N/A
N/A	Landing Slope (%)	N/A	N/A	DWS Length (in)	N/A
N/A	Landing X Slope (%)	N/A	N/A	DWS Full Width?	N/A
N/A	Landing Curb? (Y/N)	N/A	N/A	DWS Offset (in)	N/A
N/A	Shared Landing?	N/A			
N/A	Gutter Ponding?	N/A	N/A	Gutter Slope (%)	N/A
N/A	Gutter Lip Ht (in)	N/A	N/A	Gutter X Slope (%)	N/A
N/A	Painted X Walk1?	No	N/A	Painted X Walk2?	No
	X Walk 1 Direction	To E		X Walk 2 Direction	To N
N/A	X Walk 1 Width (in)	N/A	N/A	X Walk 2 Width (in)	N/A
	X Walk 1 Slope (%)	0.1		X Walk 2 Slope (%)	8.2
	X Walk 1 X Slope (%)	3.9		X Walk 2 X Slope (%)	0.3

N/A	Ramp inside XWalk1?	N/A	N/A	Ramp inside XWalk2?	N/A
	Road Slope (%)	1.3	N/A	Clear Space?	N/A
	Road X Slope (%)	4.1	N/A	Clear Space to XWalk (in)	N/A
N/A	Any Obstructions?	N/A	N/A	Storm Grate/Utility Hazard?	N/A
	Obstruction Type			Storm Grate/Utility Type	
		N/A			N/A
		No		Surface Condition? (G/P)	Poor

Possible Solutions:

Remove & Replace Curb Ramp With Two New Directional Ramps or Equivalent.
