# Access Compliance Report

## Public Rights-of-Way

### (Curb Ramps)

| Intersection ID: 2507 | Main Street: CAMBRIDGE_BAY_DR | Cross Street: SNOW_HILL_CT | Location: NE |

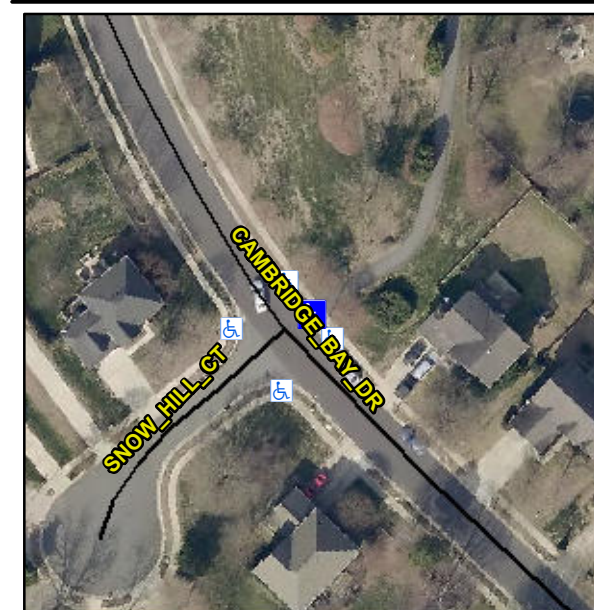
**Not Found, R304.5.3, R304.2.1,  
R304.2.2-Perp, R304.3.2-Para,  
R304.2.3, R305, R302.7.2**

| Compliance | Description | Data | Compliance | Description | Data |
|---|---|---|---|---|---|
| N/A | Ramp Length (in) | 47.0 | Yes | Ramp Slope (%) | 7.6 |
| Yes | Ramp Width (in) | 48.0 | No | Ramp XSlope (%) | 4.8 |
| No | Landing Length (in) | 47.0 | No | DWS Provided? | No |
| No | Landing Slope (%) | 5.6 | N/A | DWS Length (in) | N/A |
| No | Gutter Lip Ht (in) | 0.5 | No | Gutter X Slope (%) | 5.0 |

**Remove & Replace Entire Ramp.  
Remove & Replace Gutter.**
