# Access Compliance Report

## Public Rights-of-Way

### (Curb Ramps)

Intersection ID: 22279	Main Street: COLONY_RD	Cross Street: LORI_LN	Location: SW
ADA ID: 235A61FD4DC4	Ramp Type: PerpDiag	Initial Pass/Fail: Fail	Overall Compliance: No
Severity Score: 25			
Codes/Mitigation Info/Possible Solution		Field Measurements/Component Compliance

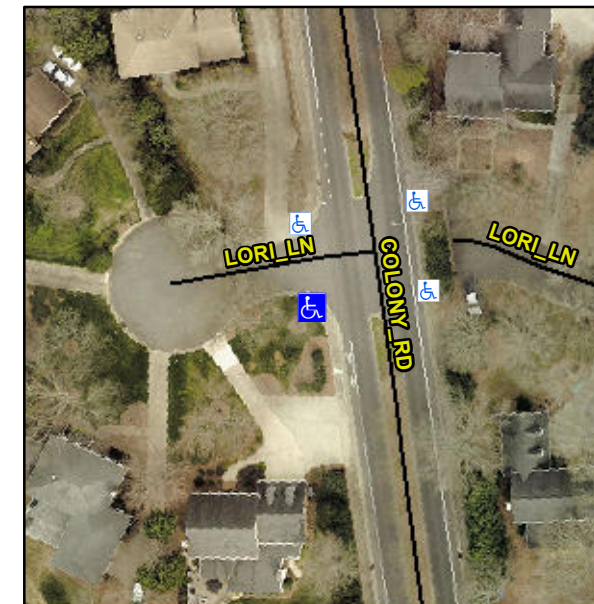
Compliance	Description	Data	Compliance	Description	Data
N/A	Ramp Length (in)	63.0	No	Ramp Slope (%)	10.9
Yes	Ramp Width (in)	48.0	No	Ramp XSlope (%)	5.1
N/A	Flare Type LT	N/A	N/A	Flare Type RT	N/A
N/A	Flare Slope LT (%)	N/A	N/A	Flare Slope RT (%)	N/A
N/A	Flare Traversable LT?	N/A	N/A	Flare Traversable RT?	N/A
N/A	Landing Length (in)	N/A	N/A	DWS Provided?	N/A
N/A	Landing Width (in)	N/A	N/A	DWS Contrast?	N/A
N/A	Landing Slope (%)	N/A	N/A	DWS Length (in)	N/A
N/A	Landing X Slope (%)	N/A	N/A	DWS Full Width?	N/A
N/A	Landing Curb? (Y/N)	N/A	N/A	DWS Offset (in)	N/A
N/A	Shared Landing?	N/A			
N/A	Gutter Ponding?	N/A	N/A	Gutter Slope (%)	N/A
N/A	Gutter Lip Ht (in)	N/A	N/A	Gutter X Slope (%)	N/A
N/A	Painted X Walk1?	No	N/A	Painted X Walk2?	No
	X Walk 1 Direction	To E		X Walk 2 Direction	To N
N/A	X Walk 1 Width (in)	N/A	N/A	X Walk 2 Width (in)	N/A
	X Walk 1 Slope (%)	4.6		X Walk 2 Slope (%)	0.1
	X Walk 1 X Slope (%)	0.8		X Walk 2 X Slope (%)	1.6

N/A	Ramp inside XWalk1?	N/A	N/A	Ramp inside XWalk2?	N/A
	Road Slope (%)	0.6	N/A	Clear Space?	N/A
	Road X Slope (%)	4.8	N/A	Clear Space to XWalk (in)	N/A
N/A	Any Obstructions?	N/A	N/A	Storm Grate/Utility Hazard?	N/A
	Obstruction Type			Storm Grate/Utility Type	
		N/A			N/A
		Yes		Surface Condition? (G/P)	Good

Possible Solutions:

**Remove & Replace Curb Ramp With Two New Directional Ramps or Equivalent.**

**R304.2.2, R304.5.3**
