Access Compliance Report Public Rights-of-Way (Curb Ramps)

Intersection ID: 17673 Main Street: MONROE_RD **Cross Street: OLD POST RD** Location: SE ADA ID: 235FD9BCE4F1 **Overall Compliance: No** Ramp Type: Directional1 Initial Pass/Fail: Pass **Severity Score:** 0.25

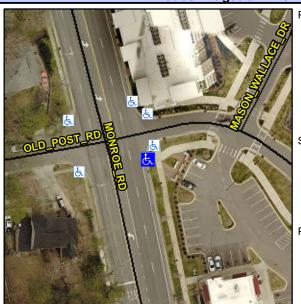
Comp	liance Description	Data	Comp	liance Description	Data
N/A	Ramp Length (in)	66.0	Yes	Grade Break?	Yes
Yes	Ramp Width (in)	93.0	Yes	Grade Break Slope (%)	1.0
Yes	Ramp Slope (%)	1.4	Yes	Grade Break XSlope (%)	0.2
No	Ramp XSlope (%)	2.8			
Yes	Flare Type LT	N/A	Yes	Flare Type RT	N/A
N/A	Flare Slope LT (%)	N/A	N/A	Flare Slope RT (%)	N/A
N/A	Flare Traversable LT?	No	N/A	Flare Traversable RT?	No
Yes	Landing Length (in)	90.0	Yes	DWS Provided?	Yes
Yes	Landing Width (in)	107.0	Yes	DWS Contrast?	Yes
Yes	Landing Slope (%)	0.9	Yes	DWS Length (in)	24.0
Yes	Landing X Slope (%)	0.3	Yes	DWS Full Width?	Yes
N/A	Landing Curb? (Y/N)	No	Yes	DWS Offset LT (in)	1.0
N/A	Shared Landing?	Yes	Yes	DWS Offset RT (in)	17.0
Yes	Gutter Ponding?	No	Yes	Gutter Slope (%)	1.0
Yes	Gutter Lip Ht (in)	0.0	Yes	Gutter X Slope (%)	1.9
N/A	Painted X Walk1?	No		Road Slope (%)	2.
	X Walk 1 Direction	To W		Road X Slope (%)	1.0
	X Walk 1 Width (in)	N/A	l	Clear Space?	Yes

X Walk 1 Slope (%)	2.7	N/A	Clear Space to XWalk (in)	N/A
	X Walk 1 X Slope (%)	1.0	Yes	Storm Grate/Utility Hazard?	No
N/A	Ramp inside XWalk1?	N/A		Storm Grate/Utility Type	
Yes	Any Obstructions?	No			N/A
	Obstruction Type		Yes	Surface Condition? (G/P)	Good
		N/A	N/A	Curb Slope (%)	4.

Possible Solutions:						
Remove & Replace Entire Ramp.						
•						
Surveyor Notes:						
N/A						
PROW/ADA:						
R304.5.3
