# Access Compliance Report

## Public Rights-of-Way

### (Curb Ramps)

Intersection ID: 48826	Main Street: DISCOVERY_LN	Cross Street: PLEASANT_GROVE_RD	Location: E
ADA ID: 2366C02323CA	Ramp Type: Perp	Initial Pass/Fail: Fail	Overall Compliance: No
Severity Score: 21.25			
Codes/Mitigation Info/Possible Solution		Field Measurements/Component Compliance

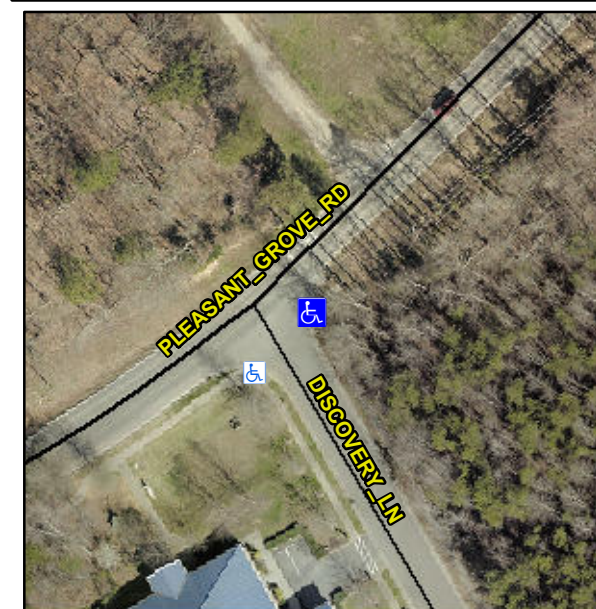
**Not Found, R304.5.1, R304.2.2**

Compliance	Description	Data	Compliance	Description	Data
N/A	Ramp Length (in)	60.0	No	Ramp Slope (%)	8.4
No	Ramp Width (in)	47.0	Yes	Ramp XSlope (%)	0.5
N/A	Flare Type LT	N/A	N/A	Flare Type RT	N/A
N/A	Flare Slope LT (%)	N/A	N/A	Flare Slope RT (%)	N/A
N/A	Flare Traversable LT?	N/A	N/A	Flare Traversable RT?	N/A
N/A	Landing Length (in)	N/A	N/A	DWS Provided?	N/A
N/A	Landing Width (in)	N/A	N/A	DWS Contrast?	N/A
N/A	Landing Slope (%)	N/A	N/A	DWS Length (in)	N/A
N/A	Landing X Slope (%)	N/A	N/A	DWS Full Width?	N/A
N/A	Landing Curb? (Y/N)	N/A	N/A	DWS Offset (in)	N/A
N/A	Shared Landing?	N/A			
N/A	Gutter Ponding?	Yes	N/A	Gutter Slope (%)	N/A
N/A	Gutter Lip Ht (in)	N/A	N/A	Gutter X Slope (%)	N/A
N/A	Painted X Walk1?	No	N/A	Painted X Walk2?	N/A
	X Walk 1 Direction	To SW		X Walk 2 Direction	N/A
N/A	X Walk 1 Width (in)	N/A	N/A	X Walk 2 Width (in)	N/A
	X Walk 1 Slope (%)	2.3		X Walk 2 Slope (%)	N/A
	X Walk 1 X Slope (%)	0.6		X Walk 2 X Slope (%)	N/A

N/A	Ramp inside XWalk1?	N/A	N/A	Ramp inside XWalk2?	N/A
	Road Slope (%)	N/A	N/A	Clear Space?	N/A
	Road X Slope (%)	N/A	N/A	Clear Space to XWalk (in)	N/A
N/A	Any Obstructions?	N/A	N/A	Storm Grate/Utility Hazard?	N/A
	Obstruction Type			Storm Grate/Utility Type	
		N/A			N/A
			Yes	Surface Condition? (G/P)	Good

**Remove & Replace Entire Ramp.**

Total Cost: \$ 1850.00
