Access Compliance Report

Public Rights-of-Way

(Curb Ramps)

Intersection ID: 29679	Main Street: CAMERON_CREEK_DR	Cross Street: SANDY_RIDGE_LN	Location: S
ADA ID: 236F14C11465	Ramp Type: BlendTrans1	Initial Pass/Fail: Fail	Overall Compliance: No
Severity Score: 8.75			
Codes/Mitigation Info/Possible Solution		Field Measurements/Component Compliance

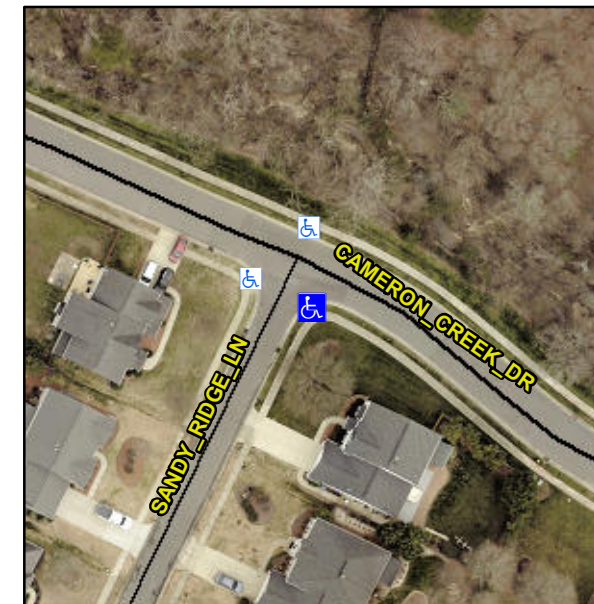
Not Found, R304.5.1

Compliance	Description	Data	Compliance	Description	Data
N/A	Ramp Length (in)	51.0	Yes	BlendTrans Slope (%)	4.4
No	Ramp Width (in)	37.5	Yes	BlendTrans XSlope (%)	0.9
N/A	Flare Type LT	N/A	N/A	Flare Type RT	N/A
N/A	Flare Slope LT (%)	N/A	N/A	Flare Slope RT (%)	N/A
N/A	Flare Traversable LT?	N/A	N/A	Flare Traversable RT?	N/A
N/A	Landing Length (in)	N/A	N/A	DWS Provided?	N/A
N/A	Landing Width (in)	N/A	N/A	DWS Contrast?	N/A
N/A	Landing Slope (%)	N/A	N/A	DWS Length (in)	N/A
N/A	Landing X Slope (%)	N/A	N/A	DWS Full Width?	N/A
N/A	Landing Curb? (Y/N)	N/A	N/A	DWS Offset (in)	N/A
N/A	Shared Landing?	N/A			
N/A	Gutter Ponding?	N/A	N/A	Gutter Slope (%)	N/A
N/A	Gutter Lip Ht (in)	N/A	N/A	Gutter X Slope (%)	N/A
N/A	Painted X Walk1?	No	N/A	Painted X Walk2?	No
	X Walk 1 Direction	To N		X Walk 2 Direction	To NW
	X Walk 1 Width (in)	N/A		X Walk 2 Width (in)	N/A
	X Walk 1 Slope (%)	2.6		X Walk 2 Slope (%)	2.6
	X Walk 1 X Slope (%)	1.1		X Walk 2 X Slope (%)	2.3

N/A	Ramp inside XWalk1?	N/A	N/A	Ramp inside XWalk2?	N/A
	Road Slope (%)	0.6		Clear Space?	N/A
	Road X Slope (%)	3.0	N/A	Clear Space to XWalk (in)	N/A
N/A	Any Obstructions?	N/A	N/A	Storm Grate/Utility Hazard?	N/A
	Obstruction Type			Storm Grate/Utility Type	
		N/A			N/A
			Yes	Surface Condition? (G/P)	Good
			No	Curb Slope (%)	8.9

Remove & Replace Curb Ramp With Two New Directional Ramps or Equivalent.
