# Access Compliance Report

## Public Rights-of-Way

### (Curb Ramps)

Intersection ID: 15660	Main Street: PRESSLEY_RD	Cross Street: ROSE_RIDGE_PL	Location: SE
ADA ID: 237137F25BFC	Ramp Type: Directional1	Initial Pass/Fail: Fail	Overall Compliance: No
Codes/Mitigation Info/Possible Solution		Field Measurements/Component Compliance	
Severity Score: 50

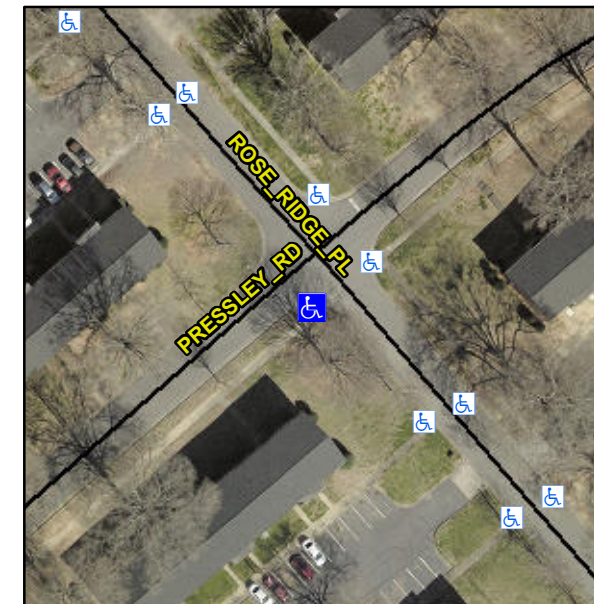
Compliance	Description	Data	Compliance	Description	Data
N/A	Ramp Length (in)	80.0	N/A	Grade Break?	N/A
Yes	Ramp Width (in)	56.0	N/A	Grade Break Slope (%)	0.0
No	Ramp Slope (%)	13.9	N/A	Grade Break XSlope (%)	0.0
No	Ramp XSlope (%)	7.4			
N/A	Flare Type LT	N/A	N/A	Flare Type RT	N/A
N/A	Flare Slope LT (%)	N/A	N/A	Flare Slope RT (%)	0.0
N/A	Flare Traversable LT?	N/A	N/A	Flare Traversable RT?	N/A
N/A	Landing Length (in)	0.0	N/A	DWS Provided?	N/A
N/A	Landing Width (in)	0.0	N/A	DWS Contrast?	N/A
N/A	Landing Slope (%)	0.0	N/A	DWS Length (in)	N/A
N/A	Landing X Slope (%)	0.0	N/A	DWS Full Width?	N/A
N/A	Landing Curb? (Y/N)	N/A	N/A	DWS Offset LT (in)	N/A
N/A	Shared Landing?	N/A	N/A	DWS Offset RT (in)	N/A
N/A	Gutter Ponding?	0.0	N/A	Gutter Slope (%)	N/A
N/A	Gutter Lip Ht (in)	1.5	N/A	Gutter X Slope (%)	N/A
N/A	Painted X Walk1?	No		Road Slope (%)	2.5
	X Walk 1 Direction	To NE		Road X Slope (%)	3.0
	X Walk 1 Width (in)	N/A		Clear Space?	N/A

X Walk 1 Slope (%)	2.5	N/A	Clear Space to XWalk (in)	N/A
	X Walk 1 X Slope (%)	3.0	N/A	Storm Grate/Utility Hazard?	N/A
N/A	Ramp inside XWalk1?	N/A		Storm Grate/Utility Type	
N/A	Any Obstructions?	N/A			N/A
	Obstruction Type		Yes	Surface Condition? (G/P)	Good
			N/A	Curb Slope (%)	22.7

**Remove & Replace Entire Ramp.**
