Access Compliance Report

Public Rights-of-Way

(Curb Ramps)

Intersection ID: 10034403	Main Street: PIEDMONT_ROW_DR_SOUTH	Cross Street: N/A	Location: SW
ADA ID: 237312B6A97C	Ramp Type: BlendTrans2	Initial Pass/Fail: Pass	Overall Compliance: No
Severity Score: 2.75			
Codes/Mitigation Info/Possible Solution		Field Measurements/Component Compliance

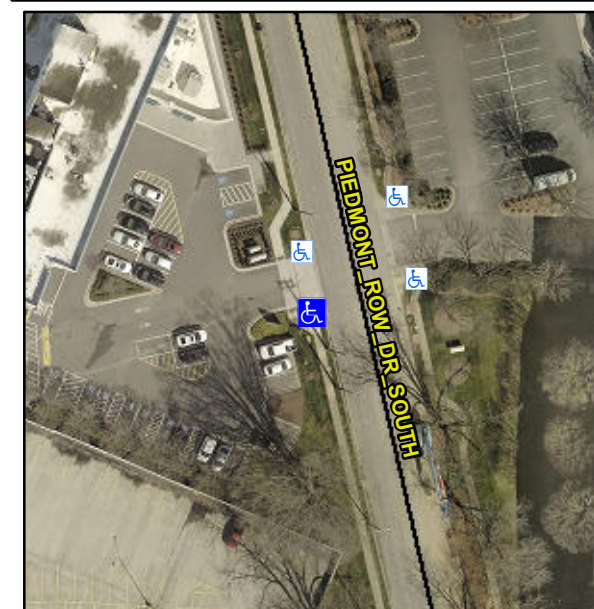
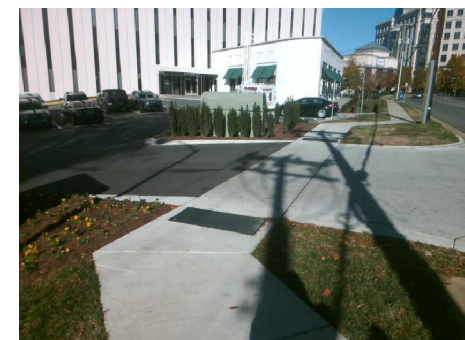
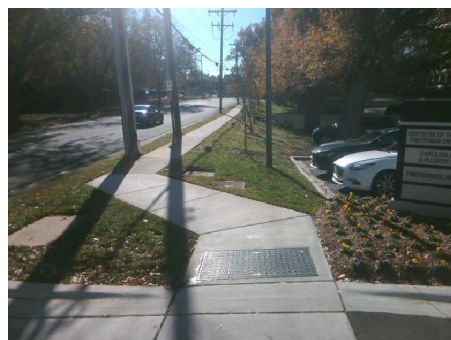
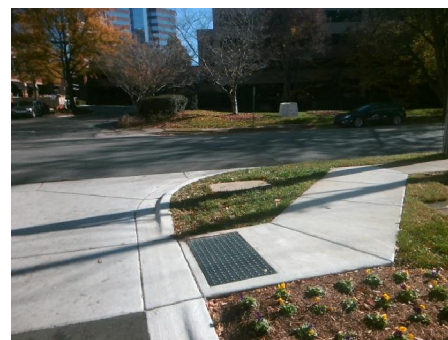
Compliance	Description	Data	Compliance	Description	Data
N/A	Ramp Length (in)	48.0	Yes	BlendTrans Slope (%)	2.2
Yes	Ramp Width (in)	60.0	No	BlendTrans XSlope (%)	2.4
N/A	Flare Type LT	None	N/A	Flare Type RT	None
N/A	Flare Slope LT (%)	N/A	N/A	Flare Slope RT (%)	N/A
N/A	Flare Traversable LT?	N/A	N/A	Flare Traversable RT?	N/A
N/A	Landing Length (in)	N/A	Yes	DWS Provided?	Yes
N/A	Landing Width (in)	N/A	Yes	DWS Contrast?	Yes
N/A	Landing Slope (%)	N/A	Yes	DWS Length (in)	24.0
N/A	Landing X Slope (%)	N/A	No	DWS Full Width?	No
N/A	Landing Curb? (Y/N)	No	No	DWS Offset (in)	3.5
N/A	Shared Landing?	No			
Yes	Gutter Ponding?	No	Yes	Gutter Slope (%)	3.4
Yes	Gutter Lip Ht (in)	0.0	Yes	Gutter X Slope (%)	1.8
N/A	Painted X Walk1?	No	N/A	Painted X Walk2?	N/A
	X Walk 1 Direction	To NW		X Walk 2 Direction	N/A
	X Walk 1 Width (in)	N/A		X Walk 2 Width (in)	N/A
	X Walk 1 Slope (%)	1.5		X Walk 2 Slope (%)	N/A
	X Walk 1 X Slope (%)	0.9		X Walk 2 X Slope (%)	N/A

N/A	Ramp inside XWalk1?	N/A	N/A	Ramp inside XWalk2?	N/A
	Road Slope (%)	0.9		Clear Space?	Yes
	Road X Slope (%)	1.5	N/A	Clear Space to XWalk (in)	N/A
Yes	Any Obstructions?	No	Yes	Storm Grate/Utility Hazard?	No
	Obstruction Type			Storm Grate/Utility Type	
			N/A		N/A
			Yes	Surface Condition? (G/P)	Good
			N/A	Curb Slope (%)	1.9

Possible Solutions:

Remove & Replace Curb Ramp With Two New Directional Ramps or Equivalent.
