# Access Compliance Report

## Public Rights-of-Way

| Intersection ID: 45518 | Main Street: COTTON_PRESS_RD | Cross Street: MEADOW_BOTTOM_RD | Location: E |
| ADA ID: 238068B6248F | Ramp Type: Combination1Diag | Initial Pass/Fail: Fail | Overall Compliance: No |

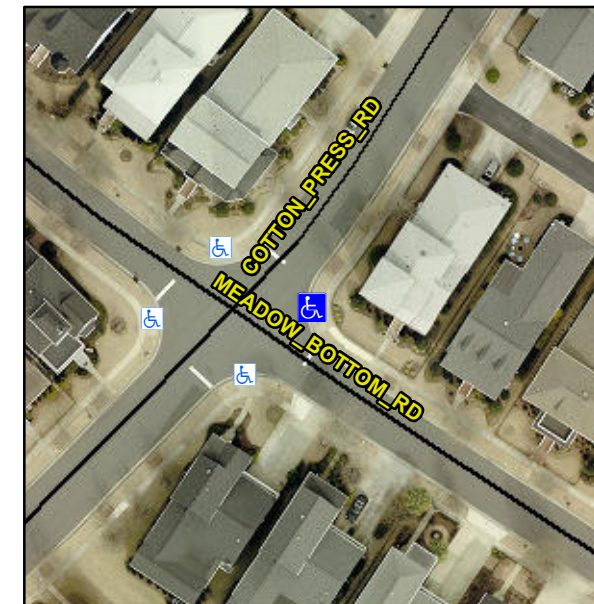
**Not Found, R304.5.1, R304.2.2, R304.5.3**

| Compliance | Description | Data | Compliance | Description | Data |
|---|---|---|---|---|---|
| Yes | Ramp XSlope LT (%) | 2.0 | No | Ramp XSlope RT (%) | 4.0 |
| N/A | Ramp Length (in) | 71.0 | No | Ramp Slope (%) | 10.7 |
| No | Ramp Width (in) | 36.0 | No | Ramp XSlope (%) | 5.9 |

**Remove & Replace Curb Ramp With Two New Directional Ramps or Equivalent.**
