# Access Compliance Report

## Public Rights-of-Way

| Intersection ID: 28284 | Main Street: LANDING_GREEN_DR | Cross Street: TOLLAND_LN | Location: W |
| ADA ID: 23845DFF231C | Ramp Type: BlendTrans1 | Initial Pass/Fail: Pass | Overall Compliance: No |

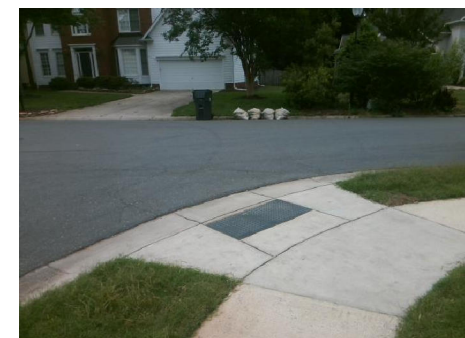
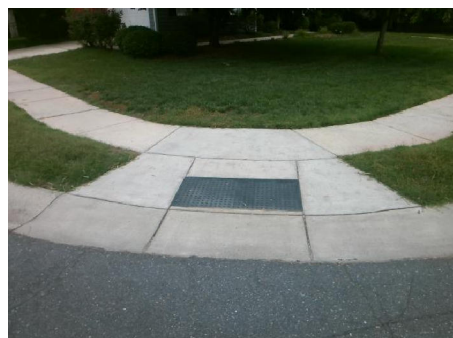
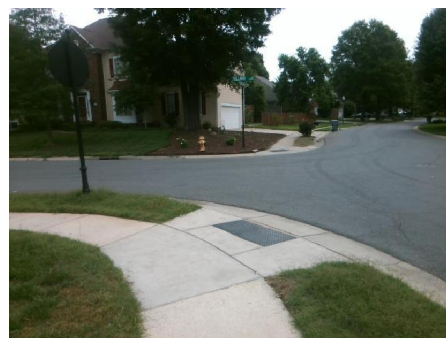
| Severity Score: 7.5 | | | |

| Compliance | Description | Data | Compliance | Description | Data |
|---|---|---|---|---|---|
| No | Landing Slope (%) | 3.4 | Yes | DWS Length (in) | 24.5 |
| N/A | Landing Curb? (Y/N) | No | No | DWS Offset (in) | 2.5 |
| No | Gutter Lip Ht (in) | 0.5 | Yes | Gutter X Slope (%) | 0.2 |
| | | | No | Curb Slope (%) | 12.7 |

**Remove & Replace Curb Ramp With Two New Directional Ramps or Equivalent.**

Total Cost: \$ 3200.00
