Access Compliance Report

Public Rights-of-Way

(Curb Ramps)

Intersection ID: 17473	Main Street: CHELTENHAM_RD	Cross Street: HEATHWOOD_RD	Location: SE
ADA ID: 23862FDD03FC	Ramp Type: PerpDiag	Initial Pass/Fail: Fail	Overall Compliance: No
Severity Score: 13.75			
Codes/Mitigation Info/Possible Solution		Field Measurements/Component Compliance

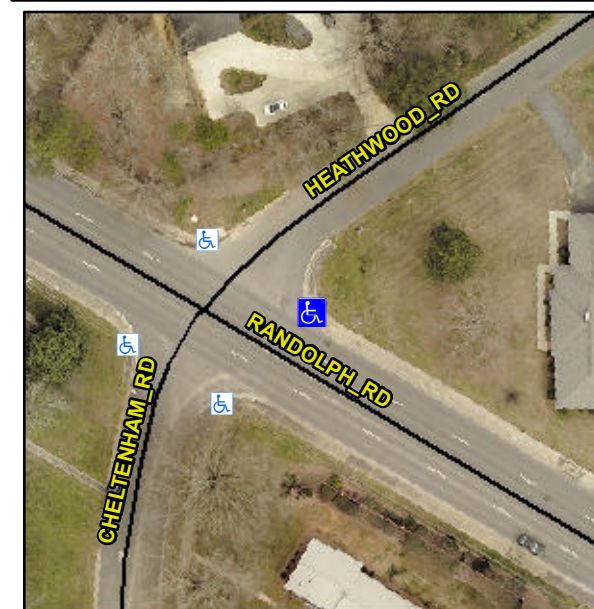
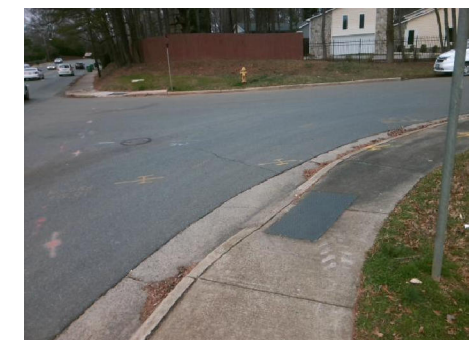
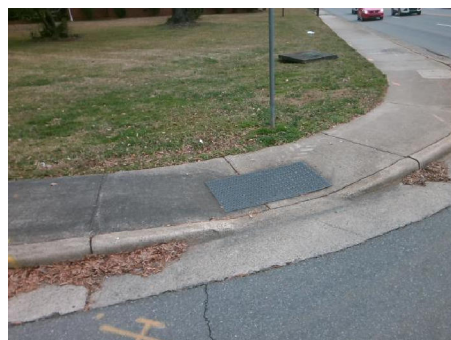
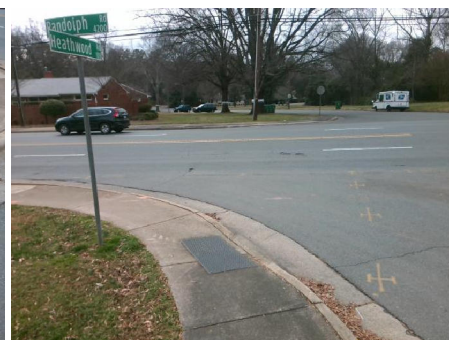
Compliance	Description	Data	Compliance	Description	Data
N/A	Ramp Length (in)	48.0	No	Ramp Slope (%)	9.9
Yes	Ramp Width (in)	48.0	No	Ramp XSlope (%)	4.1
N/A	Flare Type LT	N/A	N/A	Flare Type RT	N/A
N/A	Flare Slope LT (%)	N/A	N/A	Flare Slope RT (%)	N/A
N/A	Flare Traversable LT?	N/A	N/A	Flare Traversable RT?	N/A
N/A	Landing Length (in)	N/A	N/A	DWS Provided?	N/A
N/A	Landing Width (in)	N/A	N/A	DWS Contrast?	N/A
N/A	Landing Slope (%)	N/A	N/A	DWS Length (in)	N/A
N/A	Landing X Slope (%)	N/A	N/A	DWS Full Width?	N/A
N/A	Landing Curb? (Y/N)	N/A	N/A	DWS Offset (in)	N/A
N/A	Shared Landing?	N/A			
N/A	Gutter Ponding?	N/A	N/A	Gutter Slope (%)	N/A
N/A	Gutter Lip Ht (in)	N/A	N/A	Gutter X Slope (%)	N/A
N/A	Painted X Walk1?	No	N/A	Painted X Walk2?	No
	X Walk 1 Direction	To NW		X Walk 2 Direction	To SW
N/A	X Walk 1 Width (in)	N/A	N/A	X Walk 2 Width (in)	N/A
	X Walk 1 Slope (%)	5.4		X Walk 2 Slope (%)	2.0
	X Walk 1 X Slope (%)	3.0		X Walk 2 X Slope (%)	3.9

N/A	Ramp inside XWalk1?	N/A	N/A	Ramp inside XWalk2?	N/A
	Road Slope (%)	4.4	N/A	Clear Space?	N/A
	Road X Slope (%)	2.3	N/A	Clear Space to XWalk (in)	N/A
N/A	Any Obstructions?	N/A	N/A	Storm Grate/Utility Hazard?	N/A
	Obstruction Type			Storm Grate/Utility Type	
		N/A			N/A
		Yes		Surface Condition? (G/P)	Good

Remove & Replace Curb Ramp With Two New Directional Ramps or Equivalent.
