# Access Compliance Report

## Public Rights-of-Way

### (Curb Ramps)

Intersection ID: 27900	Main Street: FROHOCK_PL	Cross Street: HARRISON'S_CROSSING_AV	Location: NE
ADA ID: 238F935AD59D	Ramp Type: Perp	Initial Pass/Fail: Fail	Overall Compliance: No
		Severity Score: 25

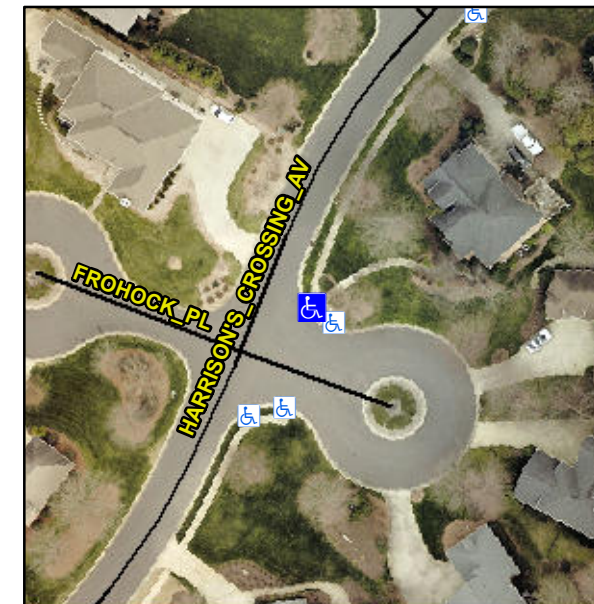
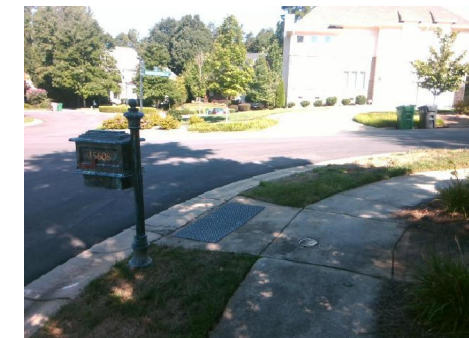
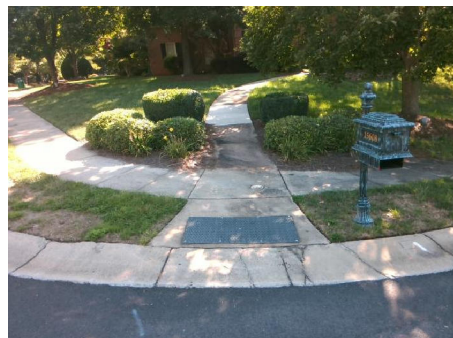
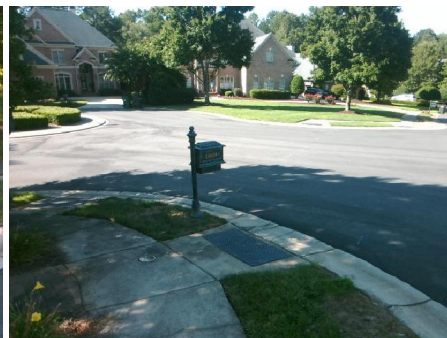
**Not Found, R304.5.3**

Compliance	Description	Data	Compliance	Description	Data
N/A	Ramp Length (in)	48.0	Yes	Ramp Slope (%)	7.6
Yes	Ramp Width (in)	48.0	No	Ramp XSlope (%)	11.1
N/A	Flare Type LT	N/A	N/A	Flare Type RT	N/A
N/A	Flare Slope LT (%)	N/A	N/A	Flare Slope RT (%)	N/A
N/A	Flare Traversable LT?	N/A	N/A	Flare Traversable RT?	N/A
N/A	Landing Length (in)	N/A	N/A	DWS Provided?	N/A
N/A	Landing Width (in)	N/A	N/A	DWS Contrast?	N/A
N/A	Landing Slope (%)	N/A	N/A	DWS Length (in)	N/A
N/A	Landing X Slope (%)	N/A	N/A	DWS Full Width?	N/A
N/A	Landing Curb? (Y/N)	N/A	N/A	DWS Offset (in)	N/A
N/A	Shared Landing?	N/A			
N/A	Gutter Ponding?	N/A	N/A	Gutter Slope (%)	N/A
N/A	Gutter Lip Ht (in)	N/A	N/A	Gutter X Slope (%)	N/A
N/A	Painted X Walk1?	No	N/A	Painted X Walk2?	N/A
	X Walk 1 Direction	To NW		X Walk 2 Direction	N/A
N/A	X Walk 1 Width (in)	N/A	N/A	X Walk 2 Width (in)	N/A
	X Walk 1 Slope (%)	6.0		X Walk 2 Slope (%)	N/A
	X Walk 1 X Slope (%)	5.0		X Walk 2 X Slope (%)	N/A

N/A	Ramp inside XWalk1?	N/A	N/A	Ramp inside XWalk2?	N/A
	Road Slope (%)	N/A	N/A	Clear Space?	N/A
	Road X Slope (%)	N/A	N/A	Clear Space to XWalk (in)	N/A
N/A	Any Obstructions?	N/A	N/A	Storm Grate/Utility Hazard?	N/A
	Obstruction Type			Storm Grate/Utility Type	
		N/A			N/A
			Yes	Surface Condition? (G/P)	Good

**Remove & Replace Entire Ramp.**

Total Cost: \$ 1850.00
