## Access Compliance Report Public Rights-of-Way (Curb Ramps)

Intersection ID: 47106	Main Str	Main Street: RUTH_POLK_CT		Street:	ERNEST_RUSSELL_C	Location:	W		
ADA ID: 239D0152D01F		Ramp Type: PerpDiag		Initial Pass/Fail: Fail Overall Compliance: N				42.5	
			initial F						72.5
Codes/Mitigation Info/Possible Solution				Field Measurements/Component Compliance					
and in 3838	AA.	Possible Solutions:		Compliance Description		Data	Data Compliance Description		Data
		Remove & Replace Curb Ramp W	Vith	N/A	Ramp Length (in)	48.0	No	Ramp Slope (%)	8.4

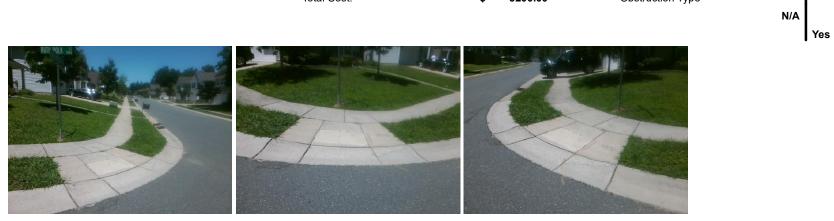
1. The set		Two New Directional Ramps or Equivalent.		No	Ramp Width (in)	35.0	No	Ramp XSlope (%)	6.4
A STA				N/A	Flare Type LT	N/A	N/A	Flare Type RT	N/A
				N/A	Flare Slope LT (%)	N/A	N/A	Flare Slope RT (%)	N/A
I I I I I I I I I I I I I I I I I I I				N/A	Flare Traversable LT?	N/A	N/A	Flare Traversable RT?	N/A
ANIAST RIVE	BOTH			N/A	Landing Length (in)	N/A	N/A	DWS Provided?	N/A
	COLLEGT COLLEGE	Surveyor Notes:		N/A	Landing Width (in)	N/A	N/A	DWS Contrast?	N/A
		N/A		N/A	Landing Slope (%)	N/A	N/A	DWS Length (in)	N/A
7 Tala 1	6			N/A	Landing X Slope (%)	N/A	N/A	DWS Full Width?	N/A
				N/A	Landing Curb? (Y/N)	N/A	N/A	DWS Offset (in)	N/A
	1199 8 11 11			N/A	Shared Landing?	N/A

A. A. A.		PROW/ADA:		N/A	Gutter Ponding?	N/A	N/A	Gutter Slope (%)	N/A
		R304.5.1, R304.2.2, R304.5.3		N/A	Gutter Lip Ht (in)	N/A	N/A	Gutter X Slope (%)	N/A
a all and a second seco		,		N/A	Painted X Walk1?	No	N/A	Painted X Walk2?	No
					X Walk 1 Direction	To SE		X Walk 2 Direction	To NE
				N/A	X Walk 1 Width (in)	N/A	N/A	X Walk 2 Width (in)	N/A
Street 1 Name	RUTH POLK CT	-			X Walk 1 Slope (%)	1.3		X Walk 2 Slope (%)	2.9
Stop Condition-Street 2	StopSign				X Walk 1 X Slope (%)	2.2		X Walk 2 X Slope (%)	2.6
Street 2 Name	ERNEST RUSSELL CT			N/A	Ramp inside XWalk1?	N/A	N/A	Ramp inside XWalk2?	N/A
Stop Condition-Street 1	None				Road Slope (%)	4.2	N/A	Clear Space?	N/A
					Road X Slope (%)	1.0		Clear Space to XWalk (in)	N/A
				N/A	Any Obstructions?	N/A		Storm Grate/Utility Hazard?	N/A
		Total Cost: \$ 3	200.00		Obstruction Type			Storm Grate/Utility Type	
		φ υ	200.00			N/A		Com Oraco, Ouncy Type	N/A
						IN/A			IN/A
