Access Compliance Report

Public Rights-of-Way

(Curb Ramps)

Intersection ID: 16670	Main Street: BEVERLY_DR	Cross Street: PROVIDENCE_RD	Location: NW
ADA ID: 23A7BC587267	Ramp Type: Perp	Initial Pass/Fail: Fail	Overall Compliance: No
		Severity Score: 8.75

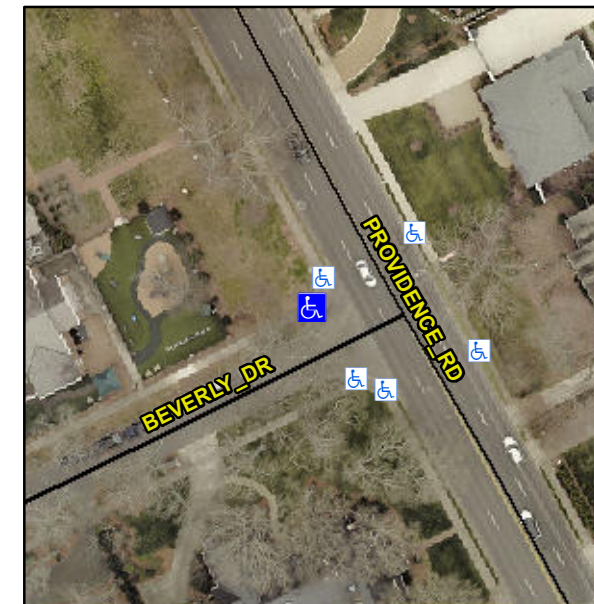
Not Found, R304.5.1

Compliance	Description	Data	Compliance	Description	Data
N/A	Ramp Length (in)	60.0	Yes	Ramp Slope (%)	5.5
No	Ramp Width (in)	46.0	Yes	Ramp XSlope (%)	0.1
N/A	Flare Type LT	N/A	N/A	Flare Type RT	N/A
N/A	Flare Slope LT (%)	N/A	N/A	Flare Slope RT (%)	N/A
N/A	Flare Traversable LT?	N/A	N/A	Flare Traversable RT?	N/A
N/A	Landing Length (in)	N/A	N/A	DWS Provided?	N/A
N/A	Landing Width (in)	N/A	N/A	DWS Contrast?	N/A
N/A	Landing Slope (%)	N/A	N/A	DWS Length (in)	N/A
N/A	Landing X Slope (%)	N/A	N/A	DWS Full Width?	N/A
N/A	Landing Curb? (Y/N)	N/A	N/A	DWS Offset (in)	N/A
N/A	Shared Landing?	N/A			
N/A	Gutter Ponding?	N/A	N/A	Gutter Slope (%)	N/A
N/A	Gutter Lip Ht (in)	N/A	N/A	Gutter X Slope (%)	N/A
N/A	Painted X Walk1?	No	N/A	Painted X Walk2?	N/A
	X Walk 1 Direction	To SE		X Walk 2 Direction	N/A
N/A	X Walk 1 Width (in)	N/A	N/A	X Walk 2 Width (in)	N/A
	X Walk 1 Slope (%)	2.8		X Walk 2 Slope (%)	N/A
	X Walk 1 X Slope (%)	0.7		X Walk 2 X Slope (%)	N/A

N/A	Ramp inside XWalk1?	N/A	N/A	Ramp inside XWalk2?	N/A
	Road Slope (%)	N/A	N/A	Clear Space?	N/A
	Road X Slope (%)	N/A	N/A	Clear Space to XWalk (in)	N/A
N/A	Any Obstructions?	N/A	N/A	Storm Grate/Utility Hazard?	N/A
	Obstruction Type			Storm Grate/Utility Type	
		N/A			N/A
			Yes	Surface Condition? (G/P)	Good

Possible Solutions:

Remove & Replace Entire Ramp.
