# Access Compliance Report

## Public Rights-of-Way

### (Curb Ramps)

Intersection ID: 21325		Main Street: RAMSGATE_RD		Cross Street: SARDIS_LN		Location: NE													
ADA ID: 23A879318039		Ramp Type: Directional1		Initial Pass/Fail: Fail		Overall Compliance: No		Severity Score: 12.5											
Codes/Mitigation Info/Possible Solution				Field Measurements/Component Compliance

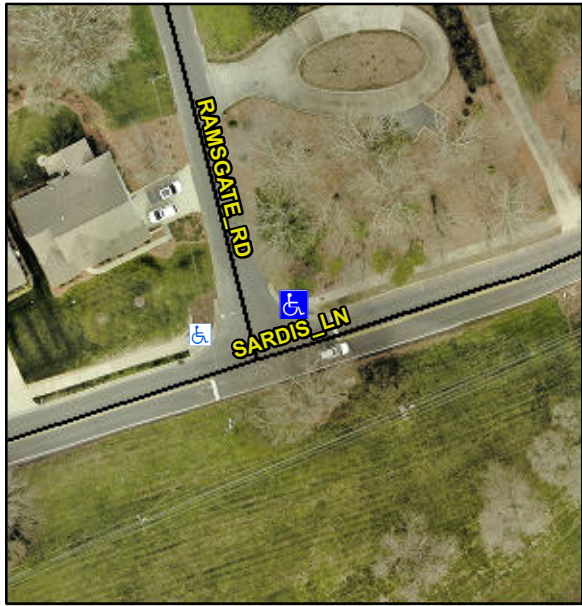
<div>Street 1 NameRAMSGATE RD</div> <div>Stop Condition-Street 1StopSign</div> <div>Street 2 NameN/A</div> <div>Stop Condition-Street 2N/A</div>				Possible Solutions:		Compliance		Description		Data		Compliance		Description		Data			
				Remove & Replace Entire Ramp.		N/A		Ramp Length (in)		24.0		N/A		Grade Break?		N/A		N/A	
						Yes		Ramp Width (in)		64.0		N/A		Grade Break Slope (%)		0.0		0.0	
						Yes		Ramp Slope (%)		1.3		N/A		Grade Break XSlope (%)		0.0			
						No		Ramp XSlope (%)		5.7									
						N/A		Flare Type LT		N/A		N/A		Flare Type RT		N/A			
						N/A		Flare Slope LT (%)		N/A		N/A		Flare Slope RT (%)		0.0

N/A		Flare Traversable LT?		N/A		N/A		Flare Traversable RT?		N/A			
						N/A		Landing Length (in)		0.0		N/A		DWS Provided?		N/A			
						N/A		Landing Width (in)		0.0		N/A		DWS Contrast?		N/A			
		N/A		Landing Slope (%)		0.0		N/A		DWS Length (in)		N/A							
		N/A		Landing X Slope (%)		0.0		N/A		DWS Full Width?		N/A							
		N/A		Landing Curb? (Y/N)		N/A		N/A		DWS Offset LT (in)		N/A							
		N/A		Shared Landing?		N/A		N/A		DWS Offset RT (in)		N/A							
		N/A		Gutter Ponding?		0.0		N/A		Gutter Slope (%)		N/A							
		N/A		Gutter Lip Ht (in)		0.0		N/A		Gutter X Slope (%)		N/A							
		N/A		Painted X Walk1?		No				Road Slope (%)		9.6							
				X Walk 1 Direction		To SW				Road X Slope (%)		0.8							
				X Walk 1 Width (in)		N/A				Clear Space?		N/A							
				X Walk 1 Slope (%)		9.6		N/A		Clear Space to XWalk (in)		N/A							
				X Walk 1 X Slope (%)		0.8		N/A		Storm Grate/Utility Hazard?		N/A

N/A		Ramp inside XWalk1?		N/A				Storm Grate/Utility Type									
		N/A		Any Obstructions?		N/A						N/A							
				Obstruction Type				Yes		Surface Condition? (G/P)		Good							
								N/A		N/A		Curb Slope (%)		9.3					
				Total Cost:		\$		1600.00											
				Surveyor Notes:		N/A													
				PROW/ADA:		R304.5.3
