## **Access Compliance Report Public Rights-of-Way** (Curb Ramps)

Main Street: CAMBRIDGE COMMONS DR Cross Street: COULPORT LN Location: Intersection ID: 28762 SE

Ramp Type: BlendTrans1 Initial Pass/Fail: Fail **Overall Compliance: No** ADA ID: 23AA3E839C60 Severity Score: 21.25

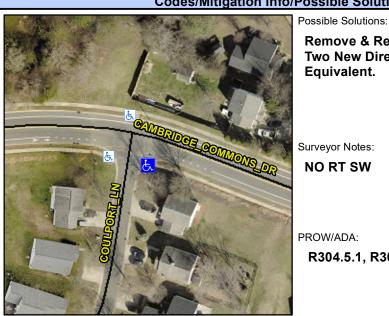
**NO RT SW**

**COULPORT LN** Street 1 Name Stop Condition-Street 1 None Street 2 Name N/A Stop Condition-Street 2 N/A Remove & Replace Curb Ramp With Two New Directional Ramps or Equivalent.

R304.5.1, R304.5.3
