Access Compliance Report

Public Rights-of-Way

(Curb Ramps)

Intersection ID: 14235	Main Street: CAMDEN_RD	Cross Street: E_TREMONT_AV	Location:	N
ADA ID: 23AB728E05F2	Ramp Type: Perp	Initial Pass/Fail: Fail	Overall Compliance: No	Severity Score: 12.5
Codes/Mitigation Info/Possible Solution		Field Measurements/Component Compliance

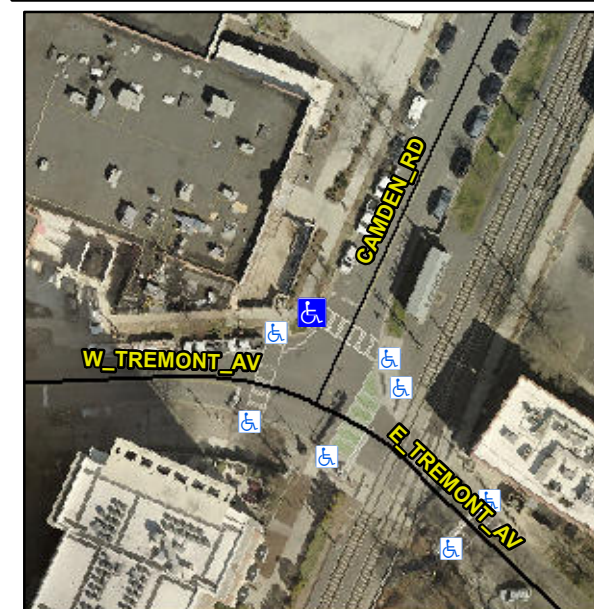
Compliance	Description	Data	Compliance	Description	Data
N/A	Ramp Length (in)	73.0	Yes	Ramp Slope (%)	5.1
Yes	Ramp Width (in)	48.0	No	Ramp XSlope (%)	6.8
N/A	Flare Type LT	N/A	N/A	Flare Type RT	N/A
N/A	Flare Slope LT (%)	N/A	N/A	Flare Slope RT (%)	N/A
N/A	Flare Traversable LT?	N/A	N/A	Flare Traversable RT?	N/A
N/A	Landing Length (in)	N/A	N/A	DWS Provided?	N/A
N/A	Landing Width (in)	N/A	N/A	DWS Contrast?	N/A
N/A	Landing Slope (%)	N/A	N/A	DWS Length (in)	N/A
N/A	Landing X Slope (%)	N/A	N/A	DWS Full Width?	N/A
N/A	Landing Curb? (Y/N)	N/A	N/A	DWS Offset (in)	N/A
N/A	Shared Landing?	N/A			
N/A	Gutter Ponding?	N/A	N/A	Gutter Slope (%)	N/A
N/A	Gutter Lip Ht (in)	N/A	N/A	Gutter X Slope (%)	N/A
N/A	Painted X Walk1?	Yes	N/A	Painted X Walk2?	N/A
	X Walk 1 Direction	To SE		X Walk 2 Direction	N/A
N/A	X Walk 1 Width (in)	109.0	N/A	X Walk 2 Width (in)	N/A
	X Walk 1 Slope (%)	3.3		X Walk 2 Slope (%)	N/A
	X Walk 1 X Slope (%)	6.1		X Walk 2 X Slope (%)	N/A

N/A	Ramp inside XWalk1?	Yes	N/A	Ramp inside XWalk2?	N/A
	Road Slope (%)	N/A	N/A	Clear Space?	N/A
	Road X Slope (%)	N/A	N/A	Clear Space to XWalk (in)	N/A
N/A	Any Obstructions?	N/A	N/A	Storm Grate/Utility Hazard?	N/A
	Obstruction Type			Storm Grate/Utility Type	
		N/A			N/A
		Yes		Surface Condition? (G/P)	Good

Possible Solutions:

Remove & Replace Entire Ramp.

R304.5.3

\$ 1850.00
