Access Compliance Report

Public Rights-of-Way (Curb Ramps)

Intersection ID: 7623	Main Street: DERRYDOWNE_DR	Cross Street: MONTEITH_DR	Location: SW
ADA ID: 23ADD85D66A6	Ramp Type: Perp	Initial Pass/Fail: Fail	Overall Compliance: No
Severity Score: 37.5			
Codes/Mitigation Info/Possible Solution		Field Measurements/Component Compliance

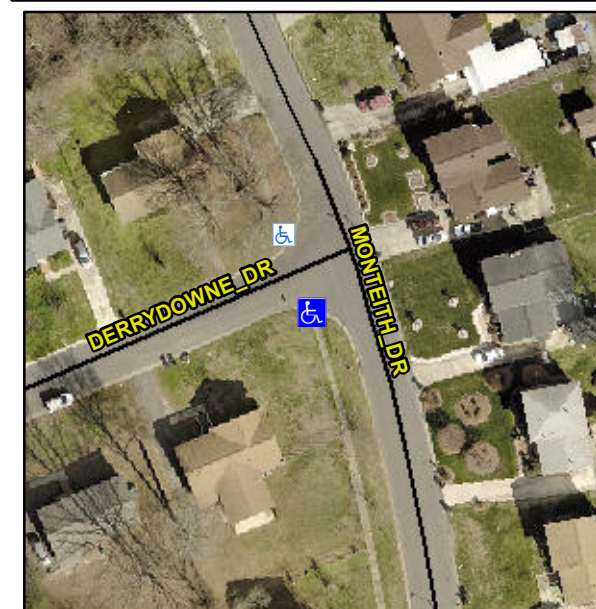
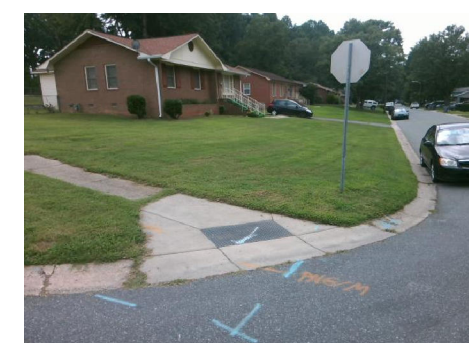
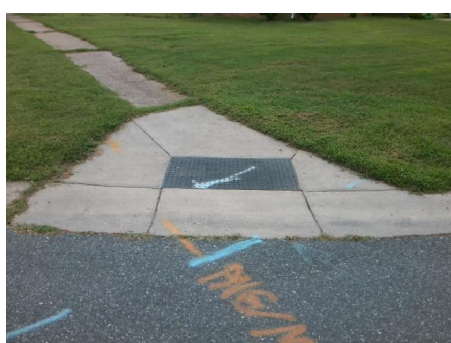
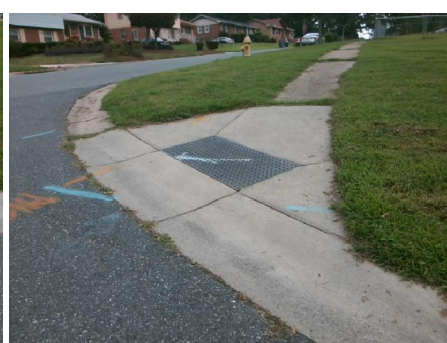
Not Found, R304.2.2, R304.5.3

Compliance	Description	Data	Compliance	Description	Data
N/A	Ramp Length (in)	24.5	No	Ramp Slope (%)	9.1
Yes	Ramp Width (in)	48.0	No	Ramp XSlope (%)	8.4
N/A	Flare Type LT	N/A	N/A	Flare Type RT	N/A
N/A	Flare Slope LT (%)	N/A	N/A	Flare Slope RT (%)	N/A
N/A	Flare Traversable LT?	N/A	N/A	Flare Traversable RT?	N/A
N/A	Landing Length (in)	N/A	N/A	DWS Provided?	N/A
N/A	Landing Width (in)	N/A	N/A	DWS Contrast?	N/A
N/A	Landing Slope (%)	N/A	N/A	DWS Length (in)	N/A
N/A	Landing X Slope (%)	N/A	N/A	DWS Full Width?	N/A
N/A	Landing Curb? (Y/N)	N/A	N/A	DWS Offset (in)	N/A
N/A	Shared Landing?	N/A			
N/A	Gutter Ponding?	N/A	N/A	Gutter Slope (%)	N/A
N/A	Gutter Lip Ht (in)	N/A	N/A	Gutter X Slope (%)	N/A
N/A	Painted X Walk1?	No	N/A	Painted X Walk2?	N/A
	X Walk 1 Direction	To N		X Walk 2 Direction	N/A
N/A	X Walk 1 Width (in)	N/A	N/A	X Walk 2 Width (in)	N/A
	X Walk 1 Slope (%)	1.4		X Walk 2 Slope (%)	N/A
	X Walk 1 X Slope (%)	6.0		X Walk 2 X Slope (%)	N/A

N/A	Ramp inside XWalk1?	N/A	N/A	Ramp inside XWalk2?	N/A
	Road Slope (%)	N/A	N/A	Clear Space?	N/A
	Road X Slope (%)	N/A	N/A	Clear Space to XWalk (in)	N/A
N/A	Any Obstructions?	N/A	N/A	Storm Grate/Utility Hazard?	N/A
	Obstruction Type			Storm Grate/Utility Type	
		N/A			N/A
		Yes		Surface Condition? (G/P)	Good

Remove & Replace Entire Ramp.

Total Cost: \$ 1850.00
