# Access Compliance Report

## Public Rights-of-Way

### (Curb Ramps)

| Intersection ID: N/A | Main Street: ALBERMARLE RD | Cross Street: CIRCUMFERENTIAL RD | Location: NE |

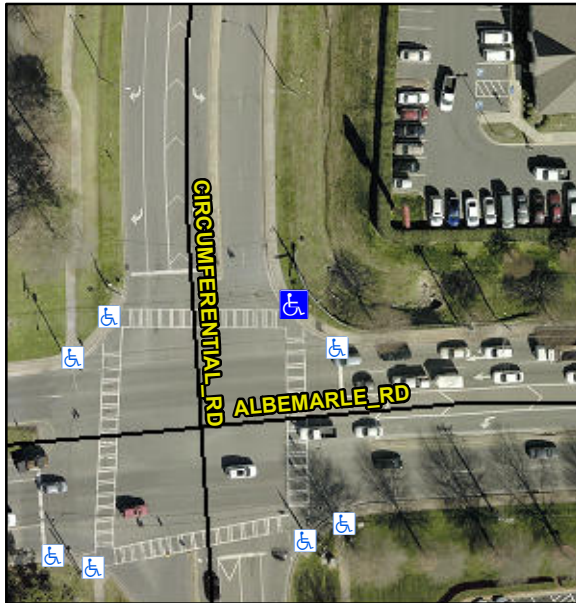
| ADA ID: 23AF15E52735 | Ramp Type: ParaDiag | Initial Pass/Fail: Pass | Overall Compliance: No |

**R304.2.2-Perp, R304.3.2-Para**

| Compliance | Description | Data | Compliance | Description | Data |
|---|---|---|---|---|---|
| No | Landing Slope (%) | 4.0 | Yes | DWS Length (in) | 24.0 |

**Remove & Replace Landing.**

Total Cost: \$ **500.00**
