Access Compliance Report

Public Rights-of-Way

(Curb Ramps)

Intersection ID: 13208	Main Street: W_CATHERINE_ST	Cross Street: WINNIFRED_ST	Location: SE
ADA ID: 23B8AEBD6FEA	Ramp Type: PerpDiag	Initial Pass/Fail: Fail	Overall Compliance: No
			Severity Score: 13.75

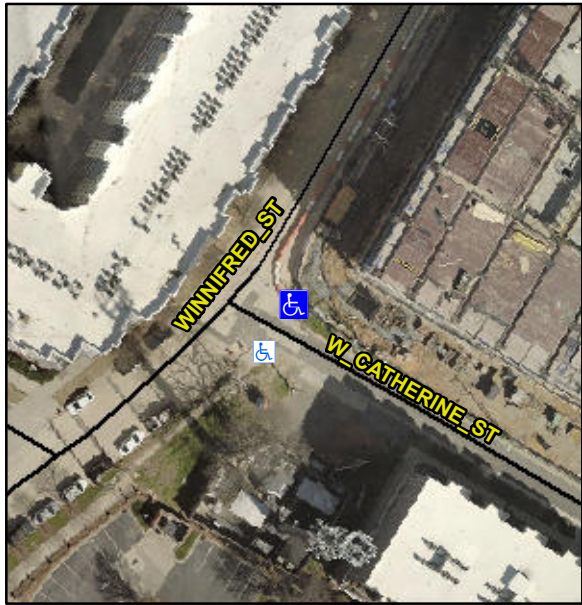
Possible Solutions:		Compliance	Description	Data	Compliance	Description	Data
	Remove & Replace Curb Ramp With Two New Directional Ramps or Equivalent.		N/A	Ramp Length (in)	95.0	No	Ramp Slope (%)	8.5
			Yes	Ramp Width (in)	48.0	No	Ramp XSlope (%)	4.0
			N/A	Flare Type LT	N/A	N/A	Flare Type RT	N/A
			N/A	Flare Slope LT (%)	N/A	N/A	Flare Slope RT (%)	N/A
			N/A	Flare Traversable LT?	N/A	N/A	Flare Traversable RT?	N/A
			N/A	Landing Length (in)	N/A	N/A	DWS Provided?	N/A
			N/A	Landing Width (in)	N/A	N/A	DWS Contrast?	N/A
			N/A	Landing Slope (%)	N/A	N/A	DWS Length (in)	N/A
			N/A	Landing X Slope (%)	N/A	N/A	DWS Full Width?	N/A
Surveyor Notes:		N/A	N/A	Landing Curb? (Y/N)	N/A	N/A	DWS Offset (in)	N/A
PROW/ADA:		Not Found, R304.2.2, R304.5.3	N/A	Shared Landing?	N/A			
			N/A	Gutter Ponding?	N/A	N/A	Gutter Slope (%)	N/A

N/A	Gutter Lip Ht (in)	N/A	N/A	Gutter X Slope (%)	N/A
			N/A	Painted X Walk1?	No	N/A	Painted X Walk2?	No
				X Walk 1 Direction	To NE		X Walk 2 Direction	To SE
			N/A	X Walk 1 Width (in)	N/A	N/A	X Walk 2 Width (in)	N/A
				X Walk 1 Slope (%)	2.5		X Walk 2 Slope (%)	3.0
				X Walk 1 X Slope (%)	0.3		X Walk 2 X Slope (%)	4.7
			N/A	Ramp inside XWalk1?	N/A	N/A	Ramp inside XWalk2?	N/A
				Road Slope (%)	1.4	N/A	Clear Space?	N/A
				Road X Slope (%)	4.8	N/A	Clear Space to XWalk (in)	N/A
			N/A	Any Obstructions?	N/A	N/A	Storm Grate/Utility Hazard?	N/A
				Obstruction Type			Storm Grate/Utility Type	
					N/A			N/A
						Yes	Surface Condition? (G/P)	Good
