Access Compliance Report

Public Rights-of-Way

(Curb Ramps)

Intersection ID: 42578	Main Street: PEACEFUL_WAY_DR	Cross Street: STROUD_PARK_CT	Location: SE
ADA ID: 23BC87AD852A	Ramp Type: PerpDiag	Initial Pass/Fail: Fail	Overall Compliance: No
		Severity Score: 17.5

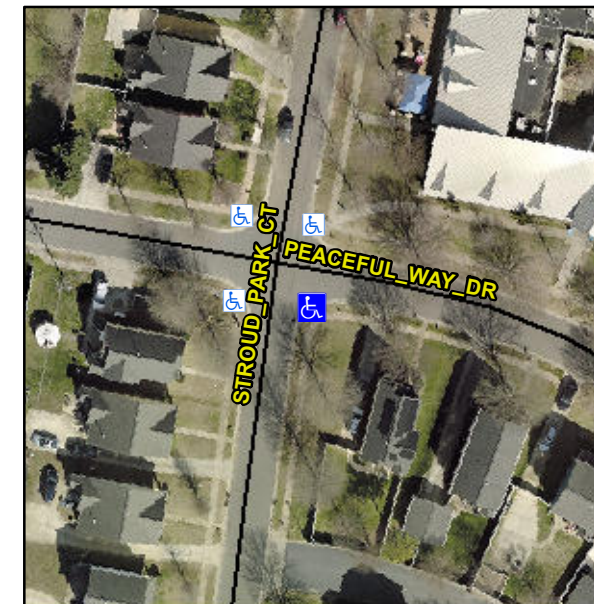
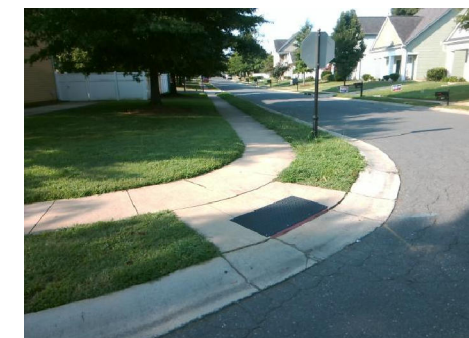
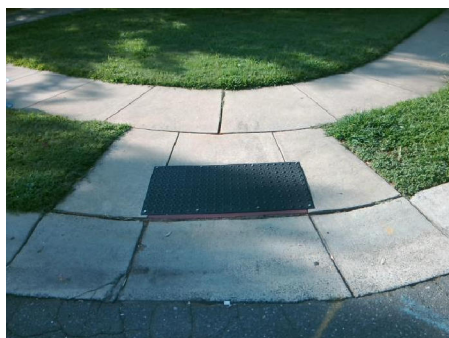
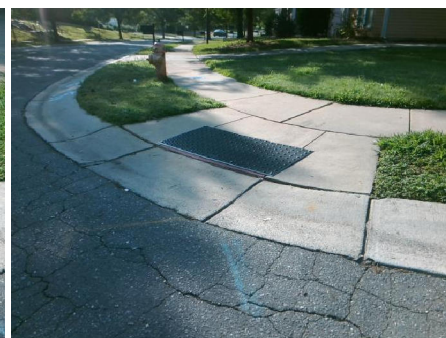
Not Found, R304.5.1

Compliance	Description	Data	Compliance	Description	Data
N/A	Ramp Length (in)	47.0	Yes	Ramp Slope (%)	5.2
No	Ramp Width (in)	35.5	Yes	Ramp XSlope (%)	0.3
N/A	Flare Type LT	N/A	N/A	Flare Type RT	N/A
N/A	Flare Slope LT (%)	N/A	N/A	Flare Slope RT (%)	N/A
N/A	Flare Traversable LT?	N/A	N/A	Flare Traversable RT?	N/A
N/A	Landing Length (in)	N/A	N/A	DWS Provided?	N/A
N/A	Landing Width (in)	N/A	N/A	DWS Contrast?	N/A
N/A	Landing Slope (%)	N/A	N/A	DWS Length (in)	N/A
N/A	Landing X Slope (%)	N/A	N/A	DWS Full Width?	N/A
N/A	Landing Curb? (Y/N)	N/A	N/A	DWS Offset (in)	N/A
N/A	Shared Landing?	N/A			
N/A	Gutter Ponding?	N/A	N/A	Gutter Slope (%)	N/A
N/A	Gutter Lip Ht (in)	N/A	N/A	Gutter X Slope (%)	N/A
N/A	Painted X Walk1?	No	N/A	Painted X Walk2?	No
	X Walk 1 Direction	To N		X Walk 2 Direction	To NW
N/A	X Walk 1 Width (in)	N/A	N/A	X Walk 2 Width (in)	N/A
	X Walk 1 Slope (%)	3.0		X Walk 2 Slope (%)	4.8
	X Walk 1 X Slope (%)	0.4		X Walk 2 X Slope (%)	0.8

N/A	Ramp inside XWalk1?	N/A	N/A	Ramp inside XWalk2?	N/A
	Road Slope (%)	0.7	N/A	Clear Space?	N/A
	Road X Slope (%)	2.3	N/A	Clear Space to XWalk (in)	N/A
N/A	Any Obstructions?	N/A	N/A	Storm Grate/Utility Hazard?	N/A
	Obstruction Type			Storm Grate/Utility Type	
		N/A			N/A
			Yes	Surface Condition? (G/P)	Good

Remove & Replace Curb Ramp With Two New Directional Ramps or Equivalent.
