Access Compliance Report

Public Rights-of-Way

(Curb Ramps)

Intersection ID: 29416	Main Street: PADDARBORN_CT	Cross Street: SALINGER_WY	Location: E
ADA ID: 23C5F6CC1EC8	Ramp Type: Perp	Initial Pass/Fail: Fail	Overall Compliance: No
Severity Score: 8.75			
Codes/Mitigation Info/Possible Solution		Field Measurements/Component Compliance

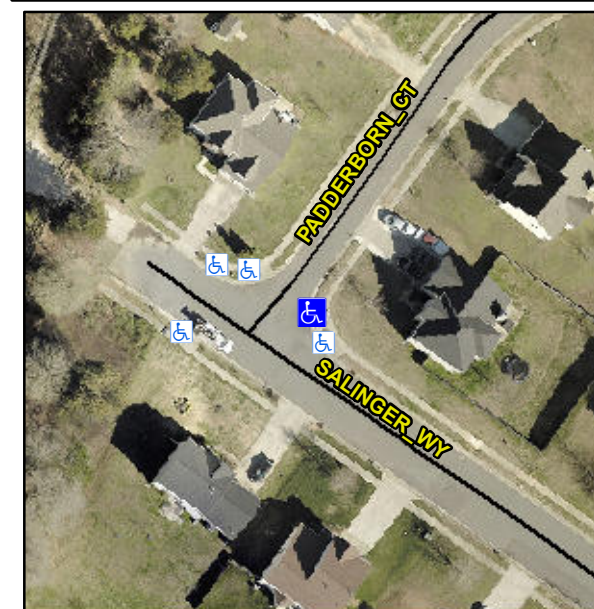
Not Found, R304.5.1

Compliance	Description	Data	Compliance	Description	Data
N/A	Ramp Length (in)	48.0	Yes	Ramp Slope (%)	8.0
No	Ramp Width (in)	47.5	Yes	Ramp XSlope (%)	1.6
N/A	Flare Type LT	N/A	N/A	Flare Type RT	N/A
N/A	Flare Slope LT (%)	N/A	N/A	Flare Slope RT (%)	N/A
N/A	Flare Traversable LT?	N/A	N/A	Flare Traversable RT?	N/A
N/A	Landing Length (in)	N/A	N/A	DWS Provided?	N/A
N/A	Landing Width (in)	N/A	N/A	DWS Contrast?	N/A
N/A	Landing Slope (%)	N/A	N/A	DWS Length (in)	N/A
N/A	Landing X Slope (%)	N/A	N/A	DWS Full Width?	N/A
N/A	Landing Curb? (Y/N)	N/A	N/A	DWS Offset (in)	N/A
N/A	Shared Landing?	N/A			
N/A	Gutter Ponding?	N/A	N/A	Gutter Slope (%)	N/A
N/A	Gutter Lip Ht (in)	0.5	N/A	Gutter X Slope (%)	N/A
N/A	Painted X Walk1?	No	N/A	Painted X Walk2?	N/A
	X Walk 1 Direction	To NW		X Walk 2 Direction	N/A
N/A	X Walk 1 Width (in)	N/A	N/A	X Walk 2 Width (in)	N/A
	X Walk 1 Slope (%)	3.7		X Walk 2 Slope (%)	N/A
	X Walk 1 X Slope (%)	1.3		X Walk 2 X Slope (%)	N/A

N/A	Ramp inside XWalk1?	N/A	N/A	Ramp inside XWalk2?	N/A
	Road Slope (%)	N/A	N/A	Clear Space?	N/A
	Road X Slope (%)	N/A	N/A	Clear Space to XWalk (in)	N/A
N/A	Any Obstructions?	N/A	N/A	Storm Grate/Utility Hazard?	N/A
	Obstruction Type			Storm Grate/Utility Type	
		N/A			N/A
			Yes	Surface Condition? (G/P)	Good

Remove & Replace Entire Ramp.
