Access Compliance Report

Public Rights-of-Way

(Curb Ramps)

Intersection ID: 30003	Main Street: CHEPSTOW_CT	Cross Street: KEMPSFORD_DR	Location:	W
ADA ID: 23CABF222639	Ramp Type: PerpDiag	Initial Pass/Fail: Fail	Overall Compliance: No	Severity Score: 1.25
Codes/Mitigation Info/Possible Solution		Field Measurements/Component Compliance

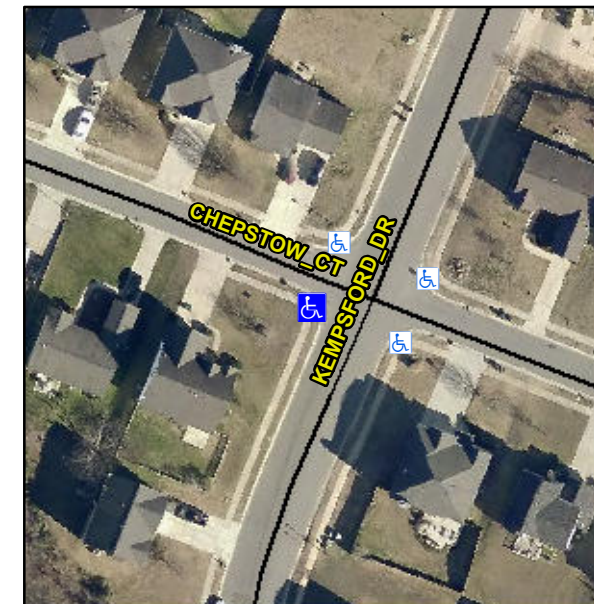
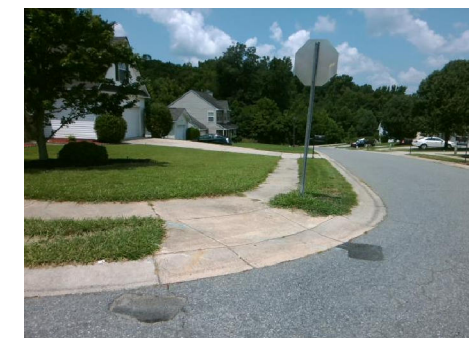
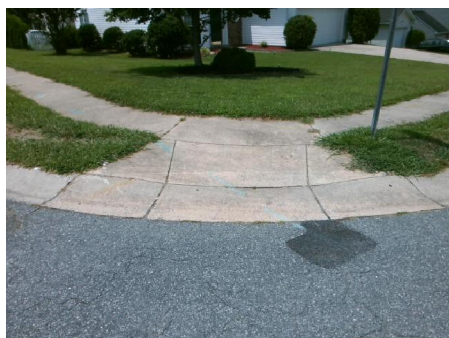
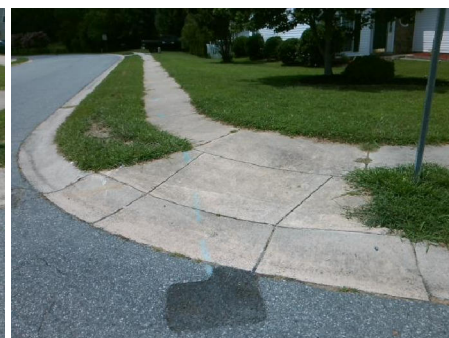
Not Found, R304.5.3

Compliance	Description	Data	Compliance	Description	Data
N/A	Ramp Length (in)	46.0	Yes	Ramp Slope (%)	5.1
Yes	Ramp Width (in)	55.0	No	Ramp XSlope (%)	2.5
N/A	Flare Type LT	N/A	N/A	Flare Type RT	N/A
N/A	Flare Slope LT (%)	N/A	N/A	Flare Slope RT (%)	N/A
N/A	Flare Traversable LT?	N/A	N/A	Flare Traversable RT?	N/A
N/A	Landing Length (in)	N/A	N/A	DWS Provided?	N/A
N/A	Landing Width (in)	N/A	N/A	DWS Contrast?	N/A
N/A	Landing Slope (%)	N/A	N/A	DWS Length (in)	N/A
N/A	Landing X Slope (%)	N/A	N/A	DWS Full Width?	N/A
N/A	Landing Curb? (Y/N)	N/A	N/A	DWS Offset (in)	N/A
N/A	Shared Landing?	N/A			
N/A	Gutter Ponding?	N/A	N/A	Gutter Slope (%)	N/A
N/A	Gutter Lip Ht (in)	N/A	N/A	Gutter X Slope (%)	N/A
N/A	Painted X Walk1?	No	N/A	Painted X Walk2?	No
	X Walk 1 Direction	To SE		X Walk 2 Direction	To NE
N/A	X Walk 1 Width (in)	N/A	N/A	X Walk 2 Width (in)	N/A
	X Walk 1 Slope (%)	4.3		X Walk 2 Slope (%)	0.0
	X Walk 1 X Slope (%)	0.6		X Walk 2 X Slope (%)	2.9

N/A	Ramp inside XWalk1?	N/A	N/A	Ramp inside XWalk2?	N/A
	Road Slope (%)	3.1	N/A	Clear Space?	N/A
	Road X Slope (%)	1.2	N/A	Clear Space to XWalk (in)	N/A
N/A	Any Obstructions?	N/A	N/A	Storm Grate/Utility Hazard?	N/A
	Obstruction Type			Storm Grate/Utility Type	
		N/A			N/A
			Yes	Surface Condition? (G/P)	Good

Remove & Replace Curb Ramp With Two New Directional Ramps or Equivalent.

Total Cost: \$ 3200.00
