# Access Compliance Report

## Public Rights-of-Way

### (Curb Ramps)

Intersection ID: 25747	Main Street: HAMILTON_RD	Cross Street: SMITH_RD	Location: NE
ADA ID: 23D626E62AF6	Ramp Type: Directional1	Initial Pass/Fail: Fail	Overall Compliance: No
		Severity Score: 25

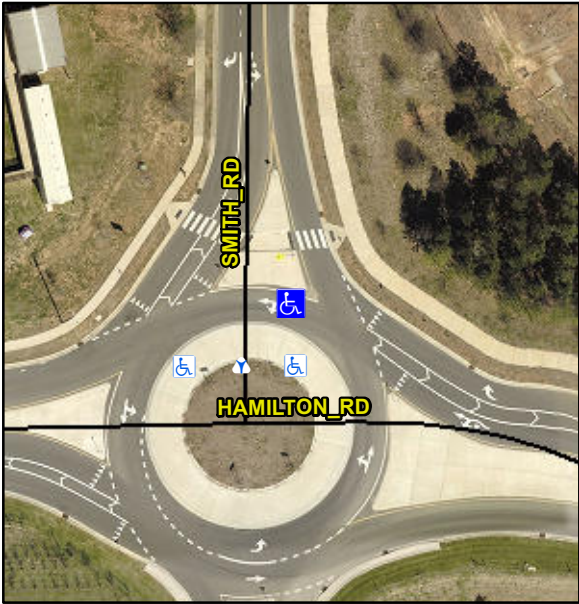
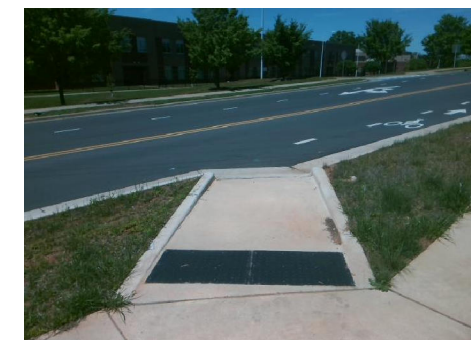
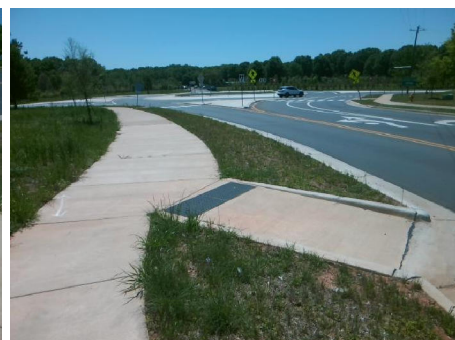
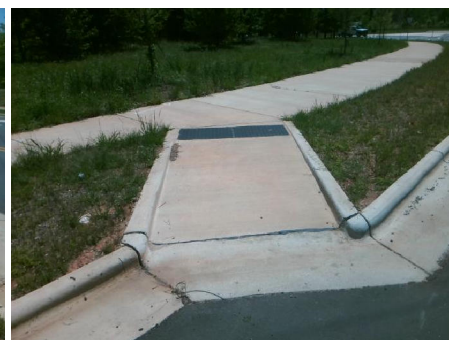
X Walk 1 X Slope (%)	<b>4.3</b>	<b>N/A</b>	Clear Space to XWalk (in)	<b>N/A</b>	
		<b>N/A</b>	Ramp inside XWalk1?	<b>N/A</b>				
		<b>N/A</b>	Any Obstructions?	<b>N/A</b>				
			Obstruction Type		<b>Yes</b>	Storm Grate/Utility Hazard?	<b>N/A</b>	
						Storm Grate/Utility Type		
					<b>Yes</b>	Surface Condition? (G/P)	<b>Good</b>	
					<b>N/A</b>	Curb Slope (%)	<b>4.8</b>

Possible Solutions:	<b>Remove &amp; Replace Entire Ramp.</b>						
	Surveyor Notes:	<b>N/A</b>						
	PROW/ADA:	<b>R304.5.3</b>						
	Street 1 Name	<b>SMITH RD</b>						
	Stop Condition-Street 1	<b>None</b>						
	Street 2 Name	<b>N/A</b>						
	Stop Condition-Street 2	<b>N/A</b>						
	Total Cost:	\$	<b>1600.00</b>					
			<b>Compliance</b>	<b>Description</b>	<b>Data</b>	<b>Compliance</b>	<b>Description</b>	<b>Data</b>
			<b>N/A</b>	Ramp Length (in)	<b>133.0</b>	<b>N/A</b>	Grade Break?	<b>N/A</b>
		<b>Yes</b>	Ramp Width (in)	<b>60.0</b>	<b>N/A</b>	Grade Break Slope (%)	<b>0.0</b>	
		<b>Yes</b>	Ramp Slope (%)	<b>6.1</b>	<b>N/A</b>	Grade Break XSlope (%)	<b>0.0</b>	
		<b>No</b>	Ramp XSlope (%)	<b>8.5</b>				
		<b>N/A</b>	Flare Type LT	<b>N/A</b>	<b>N/A</b>	Flare Type RT	<b>N/A</b>	
		<b>N/A</b>	Flare Slope LT (%)	<b>N/A</b>	<b>N/A</b>	Flare Slope RT (%)	<b>0.0</b>
