# Access Compliance Report

## Public Rights-of-Way

### (Curb Ramps)

Intersection ID: 12504	Main Street: N_BREVARD_ST	Cross Street: E_5TH_ST	Location: W
ADA ID: 23D75AFA26C9	Ramp Type: Directional1	Initial Pass/Fail: Fail	Overall Compliance: No
			Severity Score: 21.25

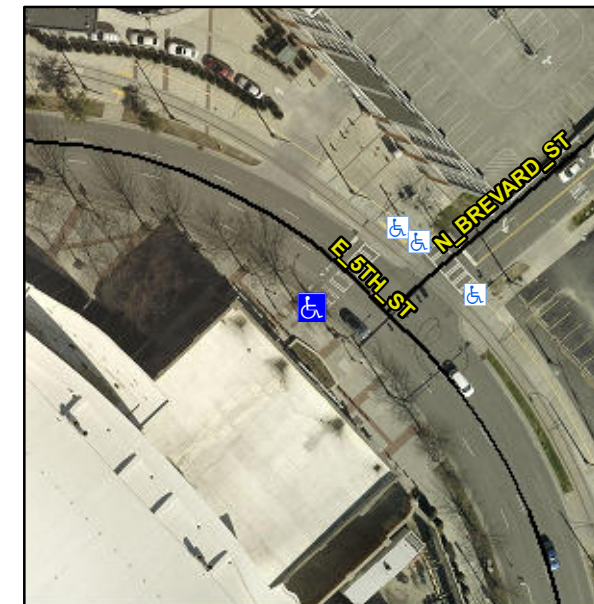
**PERP**

**R304.5.1, R304.2.2**

Compliance	Description	Data	Compliance	Description	Data
N/A	Ramp Length (in)	68.0	N/A	Grade Break?	N/A
No	Ramp Width (in)	47.0	N/A	Grade Break Slope (%)	0.0
No	Ramp Slope (%)	9.1	N/A	Grade Break XSlope (%)	0.0
Yes	Ramp XSlope (%)	1.2			
N/A	Flare Type LT	N/A	N/A	Flare Type RT	N/A
N/A	Flare Slope LT (%)	N/A	N/A	Flare Slope RT (%)	0.0
N/A	Flare Traversable LT?	N/A	N/A	Flare Traversable RT?	N/A
N/A	Landing Length (in)	0.0	N/A	DWS Provided?	N/A
N/A	Landing Width (in)	0.0	N/A	DWS Contrast?	N/A
N/A	Landing Slope (%)	0.0	N/A	DWS Length (in)	N/A
N/A	Landing X Slope (%)	0.0	N/A	DWS Full Width?	N/A
N/A	Landing Curb? (Y/N)	N/A	N/A	DWS Offset LT (in)	N/A
N/A	Shared Landing?	N/A	N/A	DWS Offset RT (in)	N/A
N/A	Gutter Ponding?	0.0	N/A	Gutter Slope (%)	N/A
N/A	Gutter Lip Ht (in)	0.0	N/A	Gutter X Slope (%)	N/A
N/A	Painted X Walk1?	Yes		Road Slope (%)	2.9
	X Walk 1 Direction	To NE		Road X Slope (%)	0.8
	X Walk 1 Width (in)	104.0		Clear Space?	N/A

X Walk 1 Slope (%)	2.9	N/A	Clear Space to XWalk (in)	N/A
	X Walk 1 X Slope (%)	0.8	N/A	Storm Grate/Utility Hazard?	N/A
N/A	Ramp inside XWalk1?	Yes		Storm Grate/Utility Type	
N/A	Any Obstructions?	N/A			N/A
	Obstruction Type		Yes	Surface Condition? (G/P)	Good
			N/A	Curb Slope (%)	2.0

**Remove & Replace Entire Ramp.**
