Access Compliance Report

Public Rights-of-Way (Curb Ramps)

Intersection ID: 7900	Main Street: EDGERTON_DR	Cross Street: SNOW_WHITE_LN	Location: SW
ADA ID: 23D7B7E76629	Ramp Type: Directional1	Initial Pass/Fail: Fail	Overall Compliance: No
Severity Score: 12.5			
Codes/Mitigation Info/Possible Solution		Field Measurements/Component Compliance

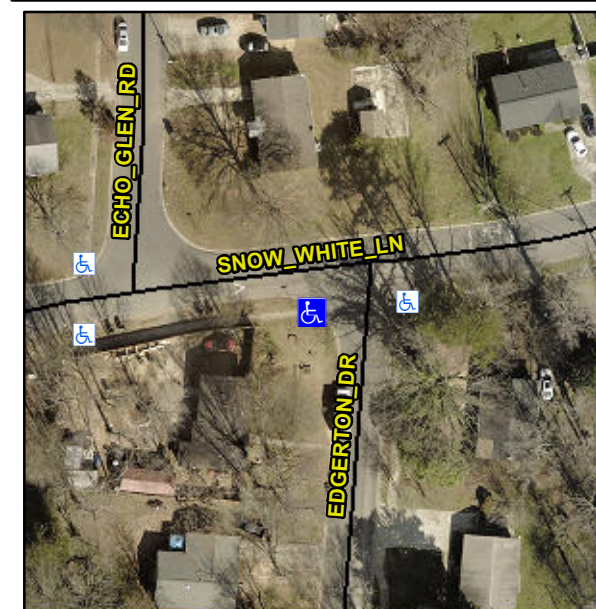
Compliance	Description	Data	Compliance	Description	Data
N/A	Ramp Length (in)	25.0	N/A	Grade Break?	N/A
Yes	Ramp Width (in)	51.0	N/A	Grade Break Slope (%)	0.0
No	Ramp Slope (%)	9.8	N/A	Grade Break XSlope (%)	0.0
Yes	Ramp XSlope (%)	1.1			
N/A	Flare Type LT	N/A	N/A	Flare Type RT	N/A
N/A	Flare Slope LT (%)	N/A	N/A	Flare Slope RT (%)	0.0
N/A	Flare Traversable LT?	N/A	N/A	Flare Traversable RT?	N/A
N/A	Landing Length (in)	0.0	N/A	DWS Provided?	N/A
N/A	Landing Width (in)	0.0	N/A	DWS Contrast?	N/A
N/A	Landing Slope (%)	0.0	N/A	DWS Length (in)	N/A
N/A	Landing X Slope (%)	0.0	N/A	DWS Full Width?	N/A
N/A	Landing Curb? (Y/N)	N/A	N/A	DWS Offset LT (in)	N/A
N/A	Shared Landing?	N/A	N/A	DWS Offset RT (in)	N/A
N/A	Gutter Ponding?	0.0	N/A	Gutter Slope (%)	N/A
N/A	Gutter Lip Ht (in)	0.0	N/A	Gutter X Slope (%)	N/A
N/A	Painted X Walk1?	No		Road Slope (%)	0.7
	X Walk 1 Direction	To E		Road X Slope (%)	4.1
	X Walk 1 Width (in)	N/A		Clear Space?	N/A

Remove & Replace Entire Ramp.

R304.2.2

\$ 1600.00

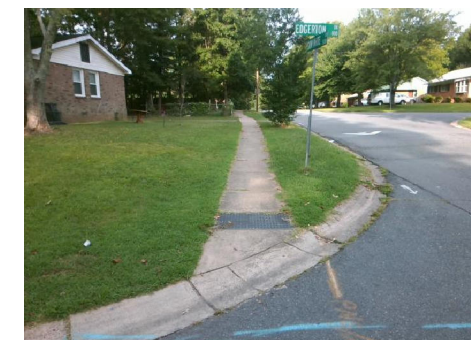
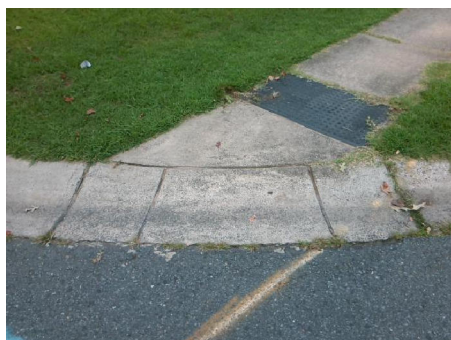
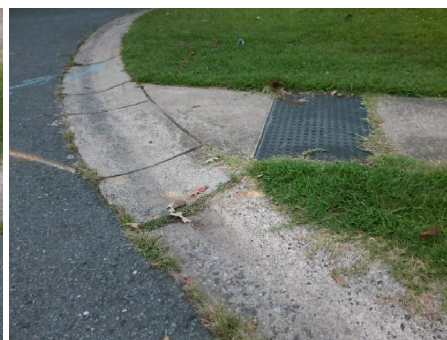
X Walk 1 Slope (%)	0.7	N/A	Clear Space to XWalk (in)	N/A
	X Walk 1 X Slope (%)	4.1	N/A	Storm Grate/Utility Hazard?	N/A
N/A	Ramp inside XWalk1?	N/A		Storm Grate/Utility Type	
N/A	Any Obstructions?	N/A			N/A
	Obstruction Type		Yes	Surface Condition? (G/P)	Good
			N/A	Curb Slope (%)	16.5
