Access Compliance Report

Public Rights-of-Way

(Curb Ramps)

Intersection ID: 10025398	Main Street: E_ARROWWOOD_RD	Cross Street: S_OAK_MARKETPLACE_DR	Location: SE
ADA ID: 23DE4B34CC20	Ramp Type: Directional1	Initial Pass/Fail: Fail	Overall Compliance: No
			Severity Score: 13.75

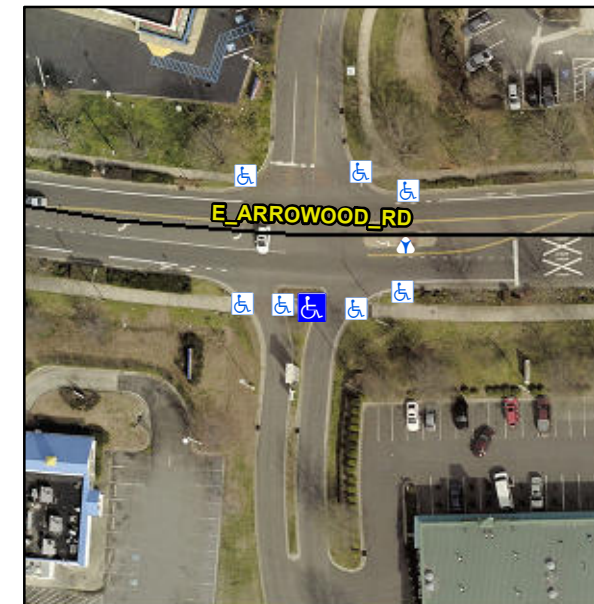
LOCATED ON MEDIAN

R304.2.2, R304.5.3

Compliance	Description	Data	Compliance	Description	Data
N/A	Ramp Length (in)	86.0	N/A	Grade Break?	N/A
Yes	Ramp Width (in)	90.0	N/A	Grade Break Slope (%)	0.0
No	Ramp Slope (%)	10.5	N/A	Grade Break XSlope (%)	0.0
No	Ramp XSlope (%)	3.8			
N/A	Flare Type LT	N/A	N/A	Flare Type RT	N/A
N/A	Flare Slope LT (%)	N/A	N/A	Flare Slope RT (%)	0.0
N/A	Flare Traversable LT?	N/A	N/A	Flare Traversable RT?	N/A
N/A	Landing Length (in)	0.0	N/A	DWS Provided?	N/A
N/A	Landing Width (in)	0.0	N/A	DWS Contrast?	N/A
N/A	Landing Slope (%)	0.0	N/A	DWS Length (in)	N/A
N/A	Landing X Slope (%)	0.0	N/A	DWS Full Width?	N/A
N/A	Landing Curb? (Y/N)	N/A	N/A	DWS Offset LT (in)	N/A
N/A	Shared Landing?	N/A	N/A	DWS Offset RT (in)	N/A
N/A	Gutter Ponding?	0.0	N/A	Gutter Slope (%)	N/A
N/A	Gutter Lip Ht (in)	0.0	N/A	Gutter X Slope (%)	N/A
N/A	Painted X Walk1?	Yes		Road Slope (%)	4.6
	X Walk 1 Direction	To E		Road X Slope (%)	0.9
	X Walk 1 Width (in)	121.0		Clear Space?	N/A

X Walk 1 Slope (%)	4.6	N/A	Clear Space to XWalk (in)	N/A
	X Walk 1 X Slope (%)	0.9	N/A	Storm Grate/Utility Hazard?	N/A
N/A	Ramp inside XWalk1?	Yes		Storm Grate/Utility Type	
N/A	Any Obstructions?	N/A			N/A
	Obstruction Type		Yes	Surface Condition? (G/P)	Good
			N/A	Curb Slope (%)	1.2

Remove & Replace Entire Ramp.

Total Cost: \$ 1600.00
