# Access Compliance Report

## Public Rights-of-Way

### (Curb Ramps)

Intersection ID: 52583	Main Street: NEW_RENAISSANCE_WY	Cross Street: BURNETTE_AV	Location: NE
ADA ID: 23F35B87C822	Ramp Type: Directional1	Initial Pass/Fail: Fail	Overall Compliance: No
Codes/Mitigation Info/Possible Solution		Field Measurements/Component Compliance	
Severity Score: 12.5

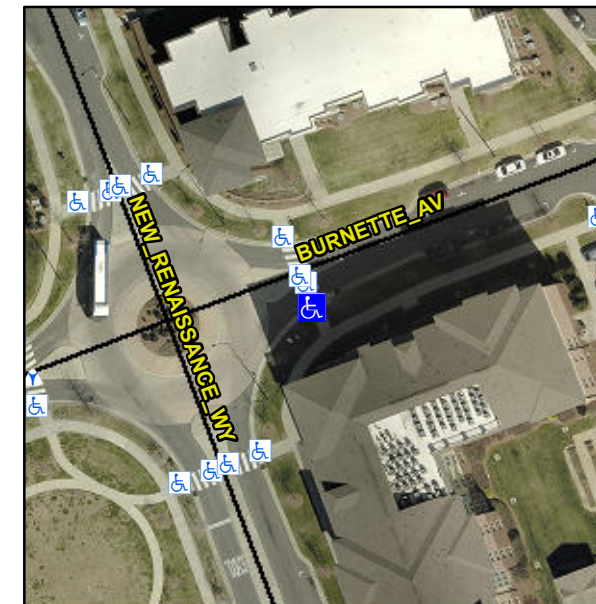
Compliance	Description	Data	Compliance	Description	Data
N/A	Ramp Length (in)	79.0	N/A	Grade Break?	N/A
Yes	Ramp Width (in)	70.0	N/A	Grade Break Slope (%)	0.0
No	Ramp Slope (%)	9.3	N/A	Grade Break XSlope (%)	0.0
Yes	Ramp XSlope (%)	1.1			
N/A	Flare Type LT	N/A	N/A	Flare Type RT	N/A
N/A	Flare Slope LT (%)	N/A	N/A	Flare Slope RT (%)	0.0
N/A	Flare Traversable LT?	N/A	N/A	Flare Traversable RT?	N/A
N/A	Landing Length (in)	0.0	N/A	DWS Provided?	N/A
N/A	Landing Width (in)	0.0	N/A	DWS Contrast?	N/A
N/A	Landing Slope (%)	0.0	N/A	DWS Length (in)	N/A
N/A	Landing X Slope (%)	0.0	N/A	DWS Full Width?	N/A
N/A	Landing Curb? (Y/N)	N/A	N/A	DWS Offset LT (in)	N/A
N/A	Shared Landing?	N/A	N/A	DWS Offset RT (in)	N/A
N/A	Gutter Ponding?	0.0	N/A	Gutter Slope (%)	N/A
N/A	Gutter Lip Ht (in)	0.0	N/A	Gutter X Slope (%)	N/A
N/A	Painted X Walk1?	Yes		Road Slope (%)	4.1
	X Walk 1 Direction	To NW		Road X Slope (%)	2.1
	X Walk 1 Width (in)	122.0		Clear Space?	N/A

X Walk 1 Slope (%)	4.1	N/A	Clear Space to XWalk (in)	N/A
	X Walk 1 X Slope (%)	2.1	N/A	Storm Grate/Utility Hazard?	N/A
N/A	Ramp inside XWalk1?	Yes		Storm Grate/Utility Type	
N/A	Any Obstructions?	N/A			N/A
	Obstruction Type		Yes	Surface Condition? (G/P)	Good
			N/A	Curb Slope (%)	7.8

**Remove & Replace Entire Ramp.**

**R304.2.2**

\$ 1600.00
