Access Compliance Report

Public Rights-of-Way

(Curb Ramps)

Intersection ID: 29274	Main Street: CHALK_HILL_LN	Cross Street: RUXTON_CT	Location: S
ADA ID: 23F54D858296	Ramp Type: BlendTrans1	Initial Pass/Fail: Fail	Overall Compliance: No
			Severity Score: 21.25

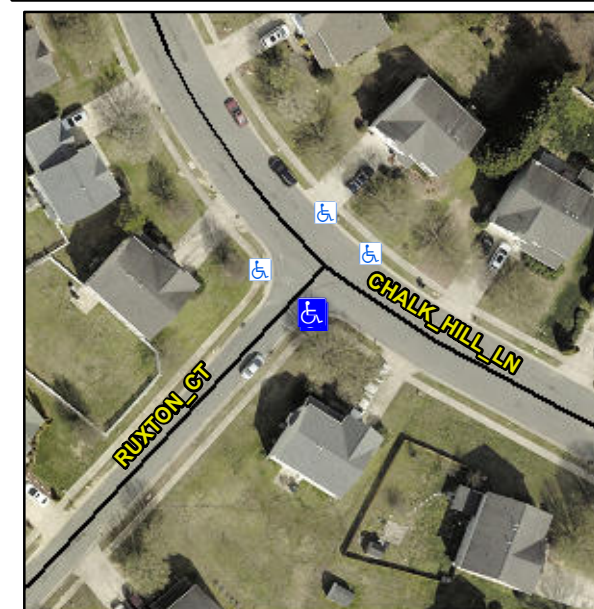
Not Found, R304.5.1, R304.5.3

Compliance	Description	Data	Compliance	Description	Data
N/A	Ramp Length (in)	45.0	Yes	BlendTrans Slope (%)	3.8
No	Ramp Width (in)	46.0	No	BlendTrans XSlope (%)	6.8
N/A	Flare Type LT	N/A	N/A	Flare Type RT	N/A
N/A	Flare Slope LT (%)	N/A	N/A	Flare Slope RT (%)	N/A
N/A	Flare Traversable LT?	N/A	N/A	Flare Traversable RT?	N/A
N/A	Landing Length (in)	N/A	N/A	DWS Provided?	N/A
N/A	Landing Width (in)	N/A	N/A	DWS Contrast?	N/A
N/A	Landing Slope (%)	N/A	N/A	DWS Length (in)	N/A
N/A	Landing X Slope (%)	N/A	N/A	DWS Full Width?	N/A
N/A	Landing Curb? (Y/N)	N/A	N/A	DWS Offset (in)	N/A
N/A	Shared Landing?	N/A			
N/A	Gutter Ponding?	N/A	N/A	Gutter Slope (%)	N/A
N/A	Gutter Lip Ht (in)	N/A	N/A	Gutter X Slope (%)	N/A
N/A	Painted X Walk1?	No	N/A	Painted X Walk2?	No
	X Walk 1 Direction	To NE		X Walk 2 Direction	To NW
	X Walk 1 Width (in)	N/A		X Walk 2 Width (in)	N/A
	X Walk 1 Slope (%)	4.9		X Walk 2 Slope (%)	4.8
	X Walk 1 X Slope (%)	1.3		X Walk 2 X Slope (%)	2.4

N/A	Ramp inside XWalk1?	N/A	N/A	Ramp inside XWalk2?	N/A
	Road Slope (%)	5.7		Clear Space?	N/A
	Road X Slope (%)	5.1	N/A	Clear Space to XWalk (in)	N/A
N/A	Any Obstructions?	N/A	N/A	Storm Grate/Utility Hazard?	N/A
	Obstruction Type			Storm Grate/Utility Type	
		N/A			N/A
			Yes	Surface Condition? (G/P)	Good
			No	Curb Slope (%)	27.4

Remove & Replace Curb Ramp With Two New Directional Ramps or Equivalent.
