# Access Compliance Report

## Public Rights-of-Way

### (Curb Ramps)

Intersection ID: 17363	Main Street: NATIONS_CROSSING_RD	Cross Street: E_EXMORE_ST	Location: W
ADA ID: 23FC4498213E	Ramp Type: PerpDiag	Initial Pass/Fail: Fail	Overall Compliance: No
Severity Score: 10			
Codes/Mitigation Info/Possible Solution		Field Measurements/Component Compliance

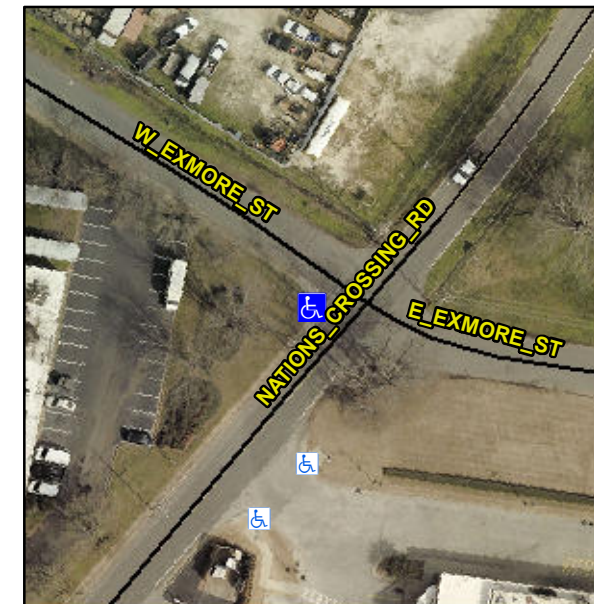
**Not Found, R304.5.1, R304.5.3**

Compliance	Description	Data	Compliance	Description	Data
N/A	Ramp Length (in)	60.0	Yes	Ramp Slope (%)	6.0
No	Ramp Width (in)	46.5	No	Ramp XSlope (%)	2.3
N/A	Flare Type LT	N/A	N/A	Flare Type RT	N/A
N/A	Flare Slope LT (%)	N/A	N/A	Flare Slope RT (%)	N/A
N/A	Flare Traversable LT?	N/A	N/A	Flare Traversable RT?	N/A
N/A	Landing Length (in)	N/A	N/A	DWS Provided?	N/A
N/A	Landing Width (in)	N/A	N/A	DWS Contrast?	N/A
N/A	Landing Slope (%)	N/A	N/A	DWS Length (in)	N/A
N/A	Landing X Slope (%)	N/A	N/A	DWS Full Width?	N/A
N/A	Landing Curb? (Y/N)	N/A	N/A	DWS Offset (in)	N/A
N/A	Shared Landing?	N/A			
N/A	Gutter Ponding?	N/A	N/A	Gutter Slope (%)	N/A
N/A	Gutter Lip Ht (in)	N/A	N/A	Gutter X Slope (%)	N/A
N/A	Painted X Walk1?	No	N/A	Painted X Walk2?	No
	X Walk 1 Direction	To SE		X Walk 2 Direction	To NE
N/A	X Walk 1 Width (in)	N/A	N/A	X Walk 2 Width (in)	N/A
	X Walk 1 Slope (%)	5.5		X Walk 2 Slope (%)	2.2
	X Walk 1 X Slope (%)	2.8		X Walk 2 X Slope (%)	3.3

N/A	Ramp inside XWalk1?	N/A	N/A	Ramp inside XWalk2?	N/A
	Road Slope (%)	0.5	N/A	Clear Space?	N/A
	Road X Slope (%)	7.4	N/A	Clear Space to XWalk (in)	N/A
N/A	Any Obstructions?	N/A	N/A	Storm Grate/Utility Hazard?	N/A
	Obstruction Type			Storm Grate/Utility Type	
		N/A			N/A
			Yes	Surface Condition? (G/P)	Good

**Remove & Replace Curb Ramp With Two New Directional Ramps or Equivalent.**
