Access Compliance Report

Public Rights-of-Way

(Curb Ramps)

Intersection ID: 48771	Main Street: LUMBER_LN	Cross Street: TURNING_WHEEL_DR	Location: SW
ADA ID: 23FF93F96CBF	Ramp Type: PerpDiag	Initial Pass/Fail: Fail	Overall Compliance: No
		Severity Score: 10

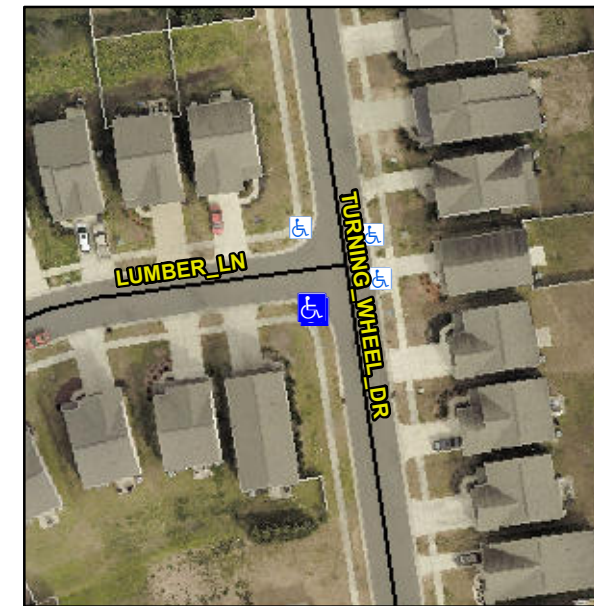
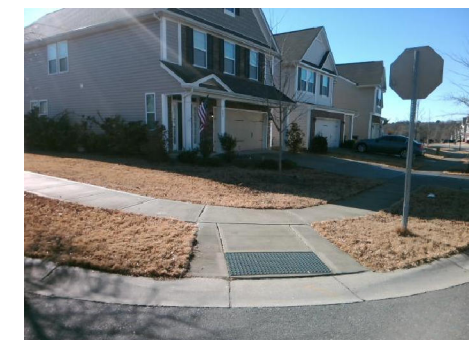
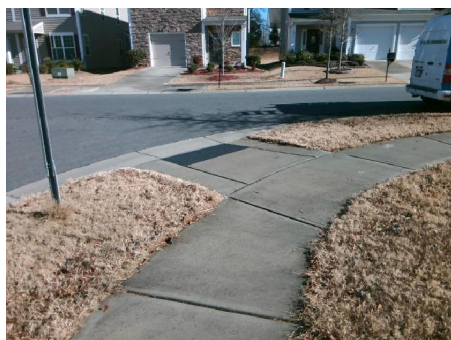
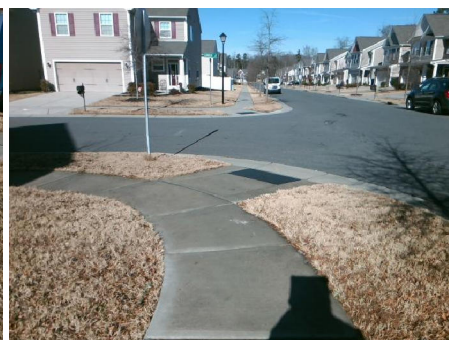
Compliance	Description	Data	Compliance	Description	Data
N/A	Ramp Length (in)	74.0	Yes	Ramp Slope (%)	5.4
No	Ramp Width (in)	47.0	No	Ramp XSlope (%)	4.2
N/A	Flare Type LT	N/A	N/A	Flare Type RT	N/A
N/A	Flare Slope LT (%)	N/A	N/A	Flare Slope RT (%)	N/A
N/A	Flare Traversable LT?	N/A	N/A	Flare Traversable RT?	N/A
N/A	Landing Length (in)	N/A	N/A	DWS Provided?	N/A
N/A	Landing Width (in)	N/A	N/A	DWS Contrast?	N/A
N/A	Landing Slope (%)	N/A	N/A	DWS Length (in)	N/A
N/A	Landing X Slope (%)	N/A	N/A	DWS Full Width?	N/A
N/A	Landing Curb? (Y/N)	N/A	N/A	DWS Offset (in)	N/A
N/A	Shared Landing?	N/A			
N/A	Gutter Ponding?	N/A	N/A	Gutter Slope (%)	N/A
N/A	Gutter Lip Ht (in)	N/A	N/A	Gutter X Slope (%)	N/A
N/A	Painted X Walk1?	No	N/A	Painted X Walk2?	No
	X Walk 1 Direction	To E		X Walk 2 Direction	To N
N/A	X Walk 1 Width (in)	N/A	N/A	X Walk 2 Width (in)	N/A
	X Walk 1 Slope (%)	5.4		X Walk 2 Slope (%)	1.6
	X Walk 1 X Slope (%)	1.3		X Walk 2 X Slope (%)	4.4

N/A	Ramp inside XWalk1?	N/A	N/A	Ramp inside XWalk2?	N/A
	Road Slope (%)	2.3	N/A	Clear Space?	N/A
	Road X Slope (%)	3.0	N/A	Clear Space to XWalk (in)	N/A
N/A	Any Obstructions?	N/A	N/A	Storm Grate/Utility Hazard?	N/A
	Obstruction Type			Storm Grate/Utility Type	
		N/A			N/A
			Yes	Surface Condition? (G/P)	Good

Remove & Replace Curb Ramp With Two New Directional Ramps or Equivalent.

R304.5.1, R304.5.3
