Access Compliance Report

Public Rights-of-Way

(Curb Ramps)

Intersection ID: 47979	Main Street: SPRINGS_MILL_RD	Cross Street: RAFFIA_RD	Location: SE
ADA ID: 2407432890E3	Ramp Type: PerpDiag	Initial Pass/Fail: Fail	Overall Compliance: No
		Severity Score: 8.75

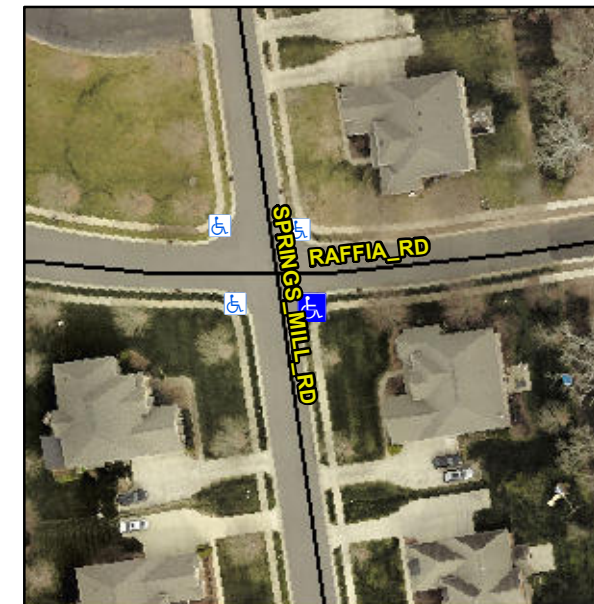
Not Found, R304.5.1

Compliance	Description	Data	Compliance	Description	Data
N/A	Ramp Length (in)	48.0	Yes	Ramp Slope (%)	7.0
No	Ramp Width (in)	46.5	Yes	Ramp XSlope (%)	1.4
N/A	Flare Type LT	N/A	N/A	Flare Type RT	N/A
N/A	Flare Slope LT (%)	N/A	N/A	Flare Slope RT (%)	N/A
N/A	Flare Traversable LT?	N/A	N/A	Flare Traversable RT?	N/A
N/A	Landing Length (in)	N/A	N/A	DWS Provided?	N/A
N/A	Landing Width (in)	N/A	N/A	DWS Contrast?	N/A
N/A	Landing Slope (%)	N/A	N/A	DWS Length (in)	N/A
N/A	Landing X Slope (%)	N/A	N/A	DWS Full Width?	N/A
N/A	Landing Curb? (Y/N)	N/A	N/A	DWS Offset (in)	N/A
N/A	Shared Landing?	N/A			
N/A	Gutter Ponding?	N/A	N/A	Gutter Slope (%)	N/A
N/A	Gutter Lip Ht (in)	N/A	N/A	Gutter X Slope (%)	N/A
N/A	Painted X Walk1?	No	N/A	Painted X Walk2?	No
	X Walk 1 Direction	To N		X Walk 2 Direction	To W
N/A	X Walk 1 Width (in)	N/A	N/A	X Walk 2 Width (in)	N/A
	X Walk 1 Slope (%)	2.2		X Walk 2 Slope (%)	3.0
	X Walk 1 X Slope (%)	2.9		X Walk 2 X Slope (%)	1.3

N/A	Ramp inside XWalk1?	N/A	N/A	Ramp inside XWalk2?	N/A
	Road Slope (%)	1.8	N/A	Clear Space?	N/A
	Road X Slope (%)	3.4	N/A	Clear Space to XWalk (in)	N/A
N/A	Any Obstructions?	N/A	N/A	Storm Grate/Utility Hazard?	N/A
	Obstruction Type			Storm Grate/Utility Type	
		N/A			N/A
			Yes	Surface Condition? (G/P)	Good

Remove & Replace Curb Ramp With Two New Directional Ramps or Equivalent.
