Access Compliance Report

Public Rights-of-Way

(Curb Ramps)

Intersection ID: 3177	Main Street: HUNTERS_WHIP_CT	Cross Street: SUTTERS_HILL_CT	Location:	N
ADA ID: 240AE9028FD1	Ramp Type: Perp	Initial Pass/Fail: Fail	Overall Compliance: No	Severity Score: 25
Codes/Mitigation Info/Possible Solution		Field Measurements/Component Compliance

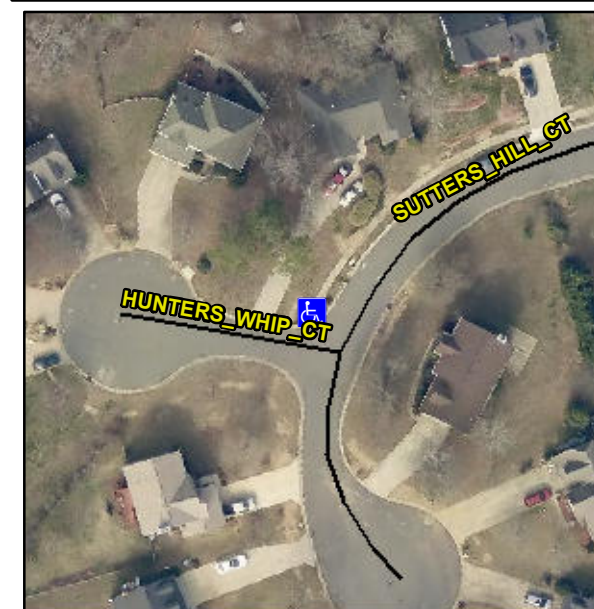
Not Found, R304.5.3

Compliance	Description	Data	Compliance	Description	Data
N/A	Ramp Length (in)	89.0	Yes	Ramp Slope (%)	6.0
Yes	Ramp Width (in)	58.5	No	Ramp XSlope (%)	9.6
N/A	Flare Type LT	N/A	N/A	Flare Type RT	N/A
N/A	Flare Slope LT (%)	N/A	N/A	Flare Slope RT (%)	N/A
N/A	Flare Traversable LT?	N/A	N/A	Flare Traversable RT?	N/A
N/A	Landing Length (in)	N/A	N/A	DWS Provided?	N/A
N/A	Landing Width (in)	N/A	N/A	DWS Contrast?	N/A
N/A	Landing Slope (%)	N/A	N/A	DWS Length (in)	N/A
N/A	Landing X Slope (%)	N/A	N/A	DWS Full Width?	N/A
N/A	Landing Curb? (Y/N)	N/A	N/A	DWS Offset (in)	N/A
N/A	Shared Landing?	N/A			
N/A	Gutter Ponding?	N/A	N/A	Gutter Slope (%)	N/A
N/A	Gutter Lip Ht (in)	N/A	N/A	Gutter X Slope (%)	N/A
N/A	Painted X Walk1?	No	N/A	Painted X Walk2?	N/A
	X Walk 1 Direction	To SW		X Walk 2 Direction	N/A
N/A	X Walk 1 Width (in)	N/A	N/A	X Walk 2 Width (in)	N/A
	X Walk 1 Slope (%)	1.7		X Walk 2 Slope (%)	N/A
	X Walk 1 X Slope (%)	3.8		X Walk 2 X Slope (%)	N/A

N/A	Ramp inside XWalk1?	N/A	N/A	Ramp inside XWalk2?	N/A
	Road Slope (%)	N/A	N/A	Clear Space?	N/A
	Road X Slope (%)	N/A	N/A	Clear Space to XWalk (in)	N/A
N/A	Any Obstructions?	N/A	N/A	Storm Grate/Utility Hazard?	N/A
	Obstruction Type			Storm Grate/Utility Type	
		N/A			N/A
			Yes	Surface Condition? (G/P)	Good

Possible Solutions:

Remove & Replace Entire Ramp.
