Access Compliance Report

Public Rights-of-Way

(Curb Ramps)

Intersection ID: 13663	Main Street: KENHILL_DR	Cross Street: WEDGEFIELD_DR	Location: NW
ADA ID: 24165B3EB333	Ramp Type: PerpDiag	Initial Pass/Fail: Fail	Overall Compliance: No
		Severity Score: 8.75

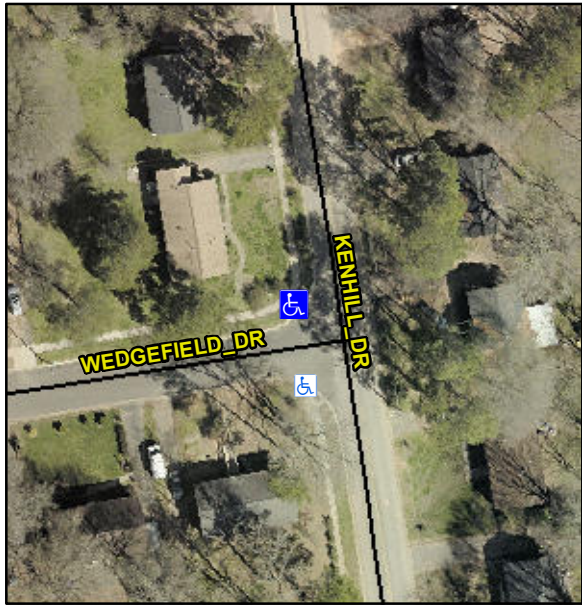
Possible Solutions:		Compliance	Description	Data	Compliance	Description	Data
	Remove & Replace Curb Ramp With Two New Directional Ramps or Equivalent.		N/A	Ramp Length (in)	71.0	Yes	Ramp Slope (%)	5.9
			No	Ramp Width (in)	41.0	Yes	Ramp XSlope (%)	0.7
			N/A	Flare Type LT	N/A	N/A	Flare Type RT	N/A
			N/A	Flare Slope LT (%)	N/A	N/A	Flare Slope RT (%)	N/A
			N/A	Flare Traversable LT?	N/A	N/A	Flare Traversable RT?	N/A
			N/A	Landing Length (in)	N/A	N/A	DWS Provided?	N/A
			N/A	Landing Width (in)	N/A	N/A	DWS Contrast?	N/A
			N/A	Landing Slope (%)	N/A	N/A	DWS Length (in)	N/A
			N/A	Landing X Slope (%)	N/A	N/A	DWS Full Width?	N/A
Surveyor Notes:	N/A		N/A	Landing Curb? (Y/N)	N/A	N/A	DWS Offset (in)	N/A
			N/A	Shared Landing?	N/A			
			N/A	Gutter Ponding?	N/A	N/A	Gutter Slope (%)	N/A
			N/A	Gutter Lip Ht (in)	N/A	N/A	Gutter X Slope (%)	N/A

N/A	Painted X Walk1?	No	N/A	Painted X Walk2?	No
				X Walk 1 Direction	To S		X Walk 2 Direction	To E
			N/A	X Walk 1 Width (in)	N/A	N/A	X Walk 2 Width (in)	N/A
				X Walk 1 Slope (%)	0.2		X Walk 2 Slope (%)	5.2
				X Walk 1 X Slope (%)	3.2		X Walk 2 X Slope (%)	0.2
			N/A	Ramp inside XWalk1?	N/A	N/A	Ramp inside XWalk2?	N/A
PROW/ADA:	Not Found, R304.5.1			Road Slope (%)	3.6	N/A	Clear Space?	N/A
				Road X Slope (%)	4.3	N/A	Clear Space to XWalk (in)	N/A
			N/A	Any Obstructions?	N/A	N/A	Storm Grate/Utility Hazard?	N/A
				Obstruction Type			Storm Grate/Utility Type	
					N/A			N/A
						Yes	Surface Condition? (G/P)	Good
Total Cost:		\$	3200.00
