Access Compliance Report

Public Rights-of-Way

(Curb Ramps)

Intersection ID: 15158	Main Street: ALBEMARLE_RD	Cross Street: WILORA_LAKE_RD	Location: NW
ADA ID: 24169F131805	Ramp Type: Perp	Initial Pass/Fail: Fail	Overall Compliance: No
Severity Score: 21.25			
Codes/Mitigation Info/Possible Solution		Field Measurements/Component Compliance

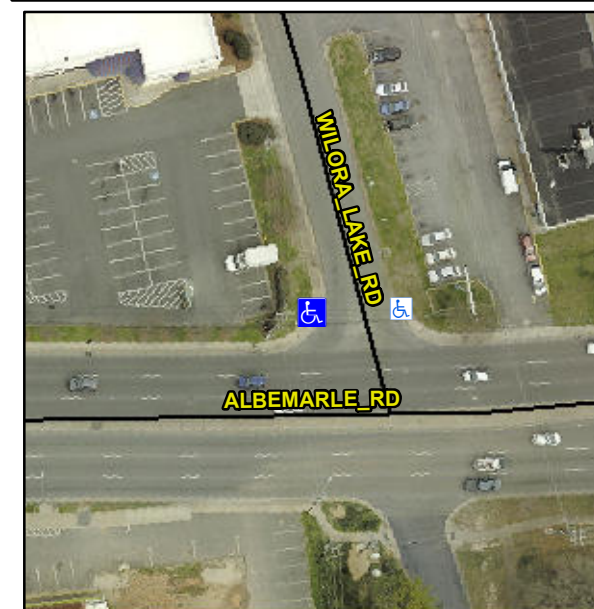
Not Found, R304.5.1, R304.2.2

Compliance	Description	Data	Compliance	Description	Data
N/A	Ramp Length (in)	59.0	No	Ramp Slope (%)	8.4
No	Ramp Width (in)	42.0	Yes	Ramp XSlope (%)	2.0
N/A	Flare Type LT	N/A	N/A	Flare Type RT	N/A
N/A	Flare Slope LT (%)	N/A	N/A	Flare Slope RT (%)	N/A
N/A	Flare Traversable LT?	N/A	N/A	Flare Traversable RT?	N/A
N/A	Landing Length (in)	N/A	N/A	DWS Provided?	N/A
N/A	Landing Width (in)	N/A	N/A	DWS Contrast?	N/A
N/A	Landing Slope (%)	N/A	N/A	DWS Length (in)	N/A
N/A	Landing X Slope (%)	N/A	N/A	DWS Full Width?	N/A
N/A	Landing Curb? (Y/N)	N/A	N/A	DWS Offset (in)	N/A
N/A	Shared Landing?	N/A			
N/A	Gutter Ponding?	N/A	N/A	Gutter Slope (%)	N/A
N/A	Gutter Lip Ht (in)	N/A	N/A	Gutter X Slope (%)	N/A
N/A	Painted X Walk1?	No	N/A	Painted X Walk2?	N/A
	X Walk 1 Direction	To E		X Walk 2 Direction	N/A
N/A	X Walk 1 Width (in)	N/A	N/A	X Walk 2 Width (in)	N/A
	X Walk 1 Slope (%)	0.3		X Walk 2 Slope (%)	N/A
	X Walk 1 X Slope (%)	1.7		X Walk 2 X Slope (%)	N/A

N/A	Ramp inside XWalk1?	N/A	N/A	Ramp inside XWalk2?	N/A
	Road Slope (%)	N/A	N/A	Clear Space?	N/A
	Road X Slope (%)	N/A	N/A	Clear Space to XWalk (in)	N/A
N/A	Any Obstructions?	N/A	N/A	Storm Grate/Utility Hazard?	N/A
	Obstruction Type			Storm Grate/Utility Type	
		N/A			N/A
			Yes	Surface Condition? (G/P)	Good

Possible Solutions:

Remove & Replace Entire Ramp.
