Access Compliance Report

Public Rights-of-Way

(Curb Ramps)

Intersection ID: 46492	Main Street: SHOPTON_RD_WEST	Cross Street: CASTLECOVE_RD	Location: W
ADA ID: 2416B616154C	Ramp Type: PerpDiag	Initial Pass/Fail: Fail	Overall Compliance: No
Severity Score: 22.5			
Codes/Mitigation Info/Possible Solution		Field Measurements/Component Compliance

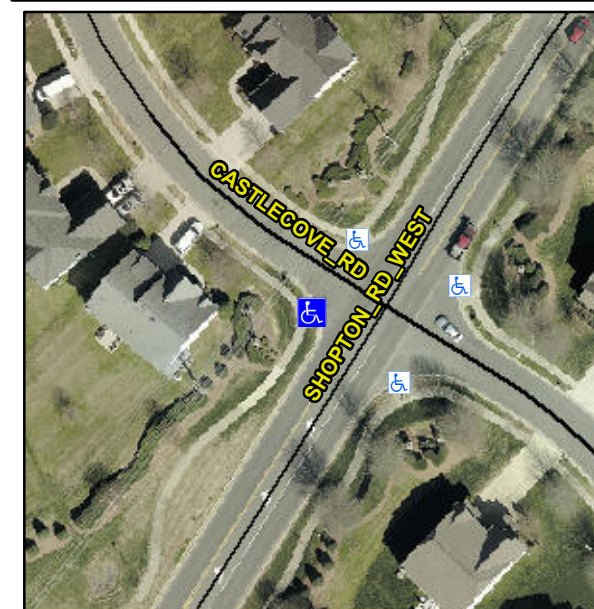
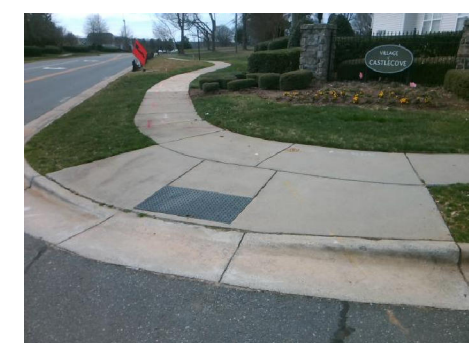
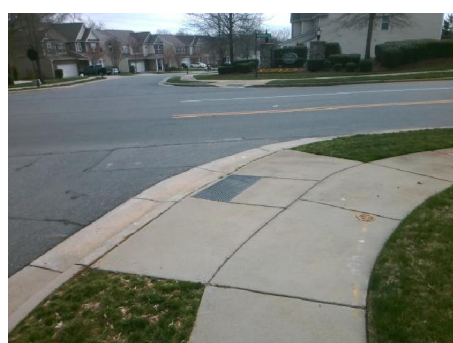
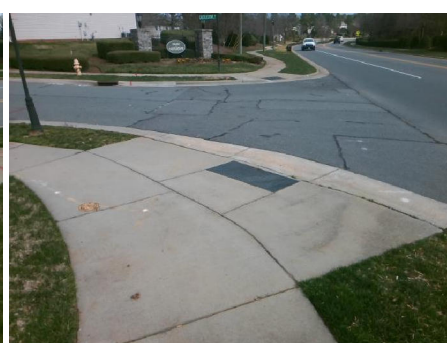
Not Found, R304.5.1, R304.2.2, R304.5.3

Compliance	Description	Data	Compliance	Description	Data
N/A	Ramp Length (in)	60.0	No	Ramp Slope (%)	9.1
No	Ramp Width (in)	47.0	No	Ramp XSlope (%)	2.5
N/A	Flare Type LT	N/A	N/A	Flare Type RT	N/A
N/A	Flare Slope LT (%)	N/A	N/A	Flare Slope RT (%)	N/A
N/A	Flare Traversable LT?	N/A	N/A	Flare Traversable RT?	N/A
N/A	Landing Length (in)	N/A	N/A	DWS Provided?	N/A
N/A	Landing Width (in)	N/A	N/A	DWS Contrast?	N/A
N/A	Landing Slope (%)	N/A	N/A	DWS Length (in)	N/A
N/A	Landing X Slope (%)	N/A	N/A	DWS Full Width?	N/A
N/A	Landing Curb? (Y/N)	N/A	N/A	DWS Offset (in)	N/A
N/A	Shared Landing?	N/A			
N/A	Gutter Ponding?	N/A	N/A	Gutter Slope (%)	N/A
N/A	Gutter Lip Ht (in)	N/A	N/A	Gutter X Slope (%)	N/A
N/A	Painted X Walk1?	No	N/A	Painted X Walk2?	No
	X Walk 1 Direction	To SE		X Walk 2 Direction	To NE
N/A	X Walk 1 Width (in)	N/A	N/A	X Walk 2 Width (in)	N/A
	X Walk 1 Slope (%)	6.2		X Walk 2 Slope (%)	1.2
	X Walk 1 X Slope (%)	1.3		X Walk 2 X Slope (%)	2.3

N/A	Ramp inside XWalk1?	N/A	N/A	Ramp inside XWalk2?	N/A
	Road Slope (%)	4.0	N/A	Clear Space?	N/A
	Road X Slope (%)	2.8	N/A	Clear Space to XWalk (in)	N/A
N/A	Any Obstructions?	N/A	N/A	Storm Grate/Utility Hazard?	N/A
	Obstruction Type			Storm Grate/Utility Type	
		N/A			N/A
			Yes	Surface Condition? (G/P)	Good

Remove & Replace Curb Ramp With Two New Directional Ramps or Equivalent.

Total Cost: \$ 3200.00
