Access Compliance Report

Public Rights-of-Way

(Curb Ramps)

Intersection ID: 11349	Main Street: N_DAVIDSON_ST	Cross Street: PARKWOOD_AV	Location: W
ADA ID: 242808FE5BD4	Ramp Type: Perp	Initial Pass/Fail: Fail	Overall Compliance: No
			Severity Score: 21.25

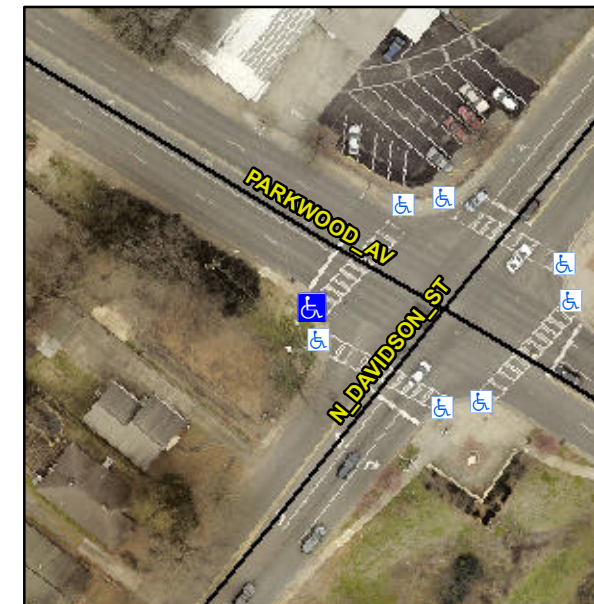
Not Found, R304.5.1, R304.2.2

Compliance	Description	Data	Compliance	Description	Data
N/A	Ramp Length (in)	62.0	No	Ramp Slope (%)	9.2
No	Ramp Width (in)	47.0	Yes	Ramp XSlope (%)	1.4
N/A	Flare Type LT	N/A	N/A	Flare Type RT	N/A
N/A	Flare Slope LT (%)	N/A	N/A	Flare Slope RT (%)	N/A
N/A	Flare Traversable LT?	N/A	N/A	Flare Traversable RT?	N/A
N/A	Landing Length (in)	N/A	N/A	DWS Provided?	N/A
N/A	Landing Width (in)	N/A	N/A	DWS Contrast?	N/A
N/A	Landing Slope (%)	N/A	N/A	DWS Length (in)	N/A
N/A	Landing X Slope (%)	N/A	N/A	DWS Full Width?	N/A
N/A	Landing Curb? (Y/N)	N/A	N/A	DWS Offset (in)	N/A
N/A	Shared Landing?	N/A			
N/A	Gutter Ponding?	N/A	N/A	Gutter Slope (%)	N/A
N/A	Gutter Lip Ht (in)	N/A	N/A	Gutter X Slope (%)	N/A
N/A	Painted X Walk1?	Yes	N/A	Painted X Walk2?	N/A
	X Walk 1 Direction	To NE		X Walk 2 Direction	N/A
N/A	X Walk 1 Width (in)	113.0	N/A	X Walk 2 Width (in)	N/A
	X Walk 1 Slope (%)	2.3		X Walk 2 Slope (%)	N/A
	X Walk 1 X Slope (%)	0.5		X Walk 2 X Slope (%)	N/A

N/A	Ramp inside XWalk1?	Yes	N/A	Ramp inside XWalk2?	N/A
	Road Slope (%)	N/A	N/A	Clear Space?	N/A
	Road X Slope (%)	N/A	N/A	Clear Space to XWalk (in)	N/A
N/A	Any Obstructions?	N/A	N/A	Storm Grate/Utility Hazard?	N/A
	Obstruction Type			Storm Grate/Utility Type	
		N/A			N/A
			Yes	Surface Condition? (G/P)	Good

Remove & Replace Entire Ramp.

Total Cost: \$ 1850.00
