# Access Compliance Report

## Public Rights-of-Way

### (Curb Ramps)

Intersection ID: 11016	Main Street: AMBASSADOR_ST	Cross Street: TUCKASEEGEE_RD	Location:	N
ADA ID: 2430A607DBC4	Ramp Type: Perp	Initial Pass/Fail: Fail	Overall Compliance: No	Severity Score: 25

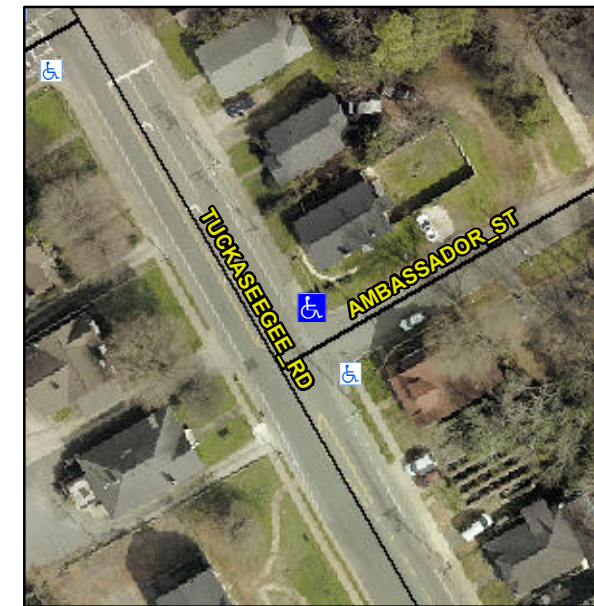
**Not Found, R304.5.3**

Compliance	Description	Data	Compliance	Description	Data
N/A	Ramp Length (in)	74.0	Yes	Ramp Slope (%)	5.8
Yes	Ramp Width (in)	48.0	No	Ramp XSlope (%)	17.6
N/A	Flare Type LT	N/A	N/A	Flare Type RT	N/A
N/A	Flare Slope LT (%)	N/A	N/A	Flare Slope RT (%)	N/A
N/A	Flare Traversable LT?	N/A	N/A	Flare Traversable RT?	N/A
N/A	Landing Length (in)	N/A	N/A	DWS Provided?	N/A
N/A	Landing Width (in)	N/A	N/A	DWS Contrast?	N/A
N/A	Landing Slope (%)	N/A	N/A	DWS Length (in)	N/A
N/A	Landing X Slope (%)	N/A	N/A	DWS Full Width?	N/A
N/A	Landing Curb? (Y/N)	N/A	N/A	DWS Offset (in)	N/A
N/A	Shared Landing?	N/A			
N/A	Gutter Ponding?	N/A	N/A	Gutter Slope (%)	N/A
N/A	Gutter Lip Ht (in)	N/A	N/A	Gutter X Slope (%)	N/A
N/A	Painted X Walk1?	No	N/A	Painted X Walk2?	N/A
	X Walk 1 Direction	To S		X Walk 2 Direction	N/A
N/A	X Walk 1 Width (in)	N/A	N/A	X Walk 2 Width (in)	N/A
	X Walk 1 Slope (%)	2.8		X Walk 2 Slope (%)	N/A
	X Walk 1 X Slope (%)	18.8		X Walk 2 X Slope (%)	N/A

N/A	Ramp inside XWalk1?	N/A	N/A	Ramp inside XWalk2?	N/A
	Road Slope (%)	N/A	N/A	Clear Space?	N/A
	Road X Slope (%)	N/A	N/A	Clear Space to XWalk (in)	N/A
N/A	Any Obstructions?	N/A	N/A	Storm Grate/Utility Hazard?	N/A
	Obstruction Type			Storm Grate/Utility Type	
		N/A			N/A
			Yes	Surface Condition? (G/P)	Good

**Remove & Replace Entire Ramp.**
