# Access Compliance Report

## Public Rights-of-Way

### (Curb Ramps)

Intersection ID: 53894	Main Street: INVERNESS_BAY_RD	Cross Street: PERTH_MOOR_RD	Location: NE
ADA ID: 2439FA1D3604	Ramp Type: Perp	Initial Pass/Fail: Fail	Overall Compliance: No
Severity Score: 12.5			
Codes/Mitigation Info/Possible Solution		Field Measurements/Component Compliance

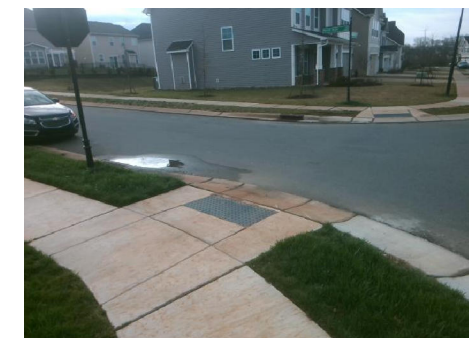
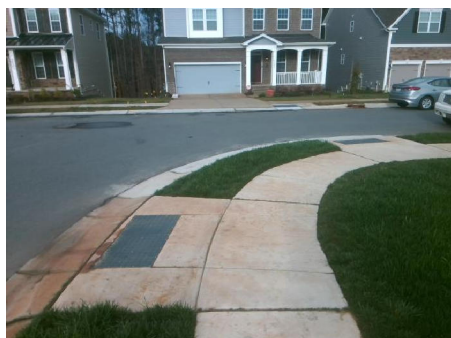
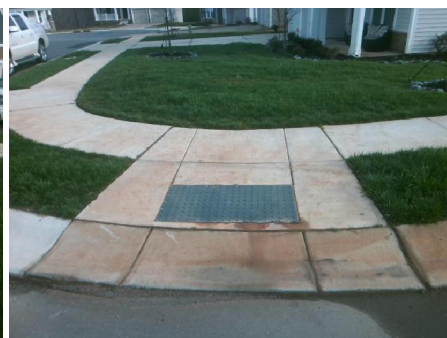
**Not Found, R304.2.2**

Compliance	Description	Data	Compliance	Description	Data
N/A	Ramp Length (in)	48.0	No	Ramp Slope (%)	8.6
Yes	Ramp Width (in)	48.0	Yes	Ramp XSlope (%)	0.5
N/A	Flare Type LT	N/A	N/A	Flare Type RT	N/A
N/A	Flare Slope LT (%)	N/A	N/A	Flare Slope RT (%)	N/A
N/A	Flare Traversable LT?	N/A	N/A	Flare Traversable RT?	N/A
N/A	Landing Length (in)	N/A	N/A	DWS Provided?	N/A
N/A	Landing Width (in)	N/A	N/A	DWS Contrast?	N/A
N/A	Landing Slope (%)	N/A	N/A	DWS Length (in)	N/A
N/A	Landing X Slope (%)	N/A	N/A	DWS Full Width?	N/A
N/A	Landing Curb? (Y/N)	N/A	N/A	DWS Offset (in)	N/A
N/A	Shared Landing?	N/A			
N/A	Gutter Ponding?	N/A	N/A	Gutter Slope (%)	N/A
N/A	Gutter Lip Ht (in)	1.5	N/A	Gutter X Slope (%)	N/A
N/A	Painted X Walk1?	No	N/A	Painted X Walk2?	N/A
	X Walk 1 Direction	To S		X Walk 2 Direction	N/A
N/A	X Walk 1 Width (in)	N/A	N/A	X Walk 2 Width (in)	N/A
	X Walk 1 Slope (%)	1.2		X Walk 2 Slope (%)	N/A
	X Walk 1 X Slope (%)	1.0		X Walk 2 X Slope (%)	N/A

N/A	Ramp inside XWalk1?	N/A	N/A	Ramp inside XWalk2?	N/A
	Road Slope (%)	N/A	N/A	Clear Space?	N/A
	Road X Slope (%)	N/A	N/A	Clear Space to XWalk (in)	N/A
N/A	Any Obstructions?	N/A	N/A	Storm Grate/Utility Hazard?	N/A
	Obstruction Type			Storm Grate/Utility Type	
		N/A			N/A
			Yes	Surface Condition? (G/P)	Good

Possible Solutions:

**Remove & Replace Entire Ramp.**

Total Cost: \$ 1850.00
